# **PLAYGROUND ASSESSMENT FOR**

## **THE CITY OF SUMMIT**

**CITY OF SUMMIT, COUNTY OF UNION, STATE OF NEW JERSEY**

**June 2022**

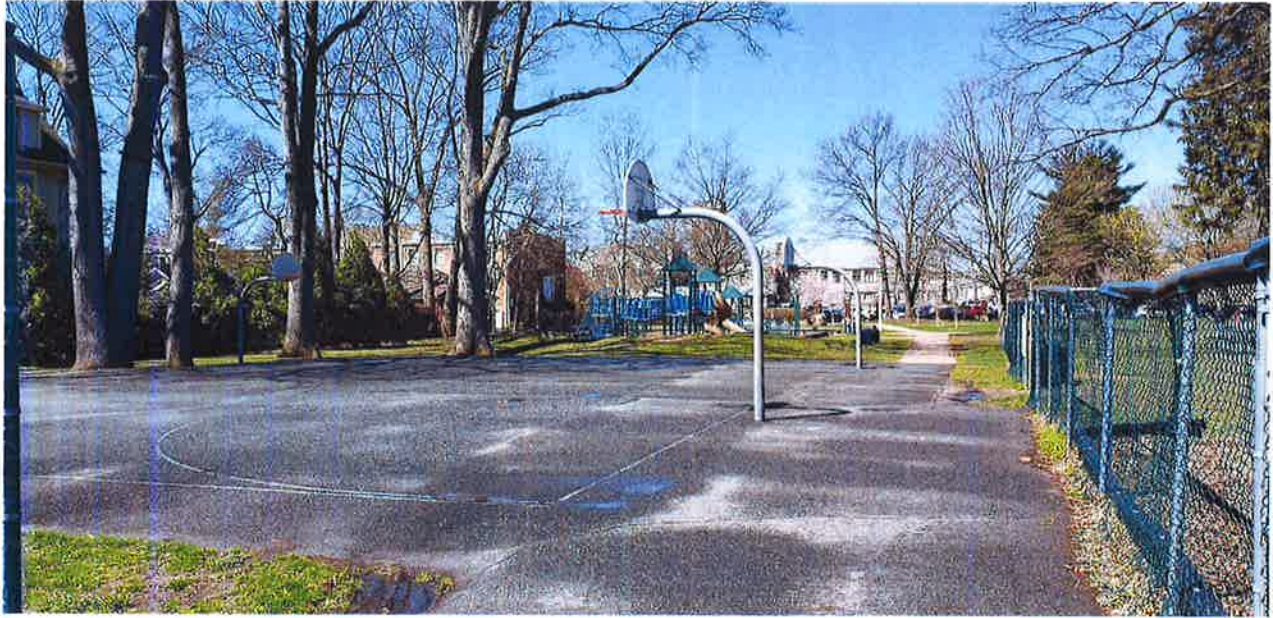
Approach to Mabie Park Playground from Summit Avenue sidewalk

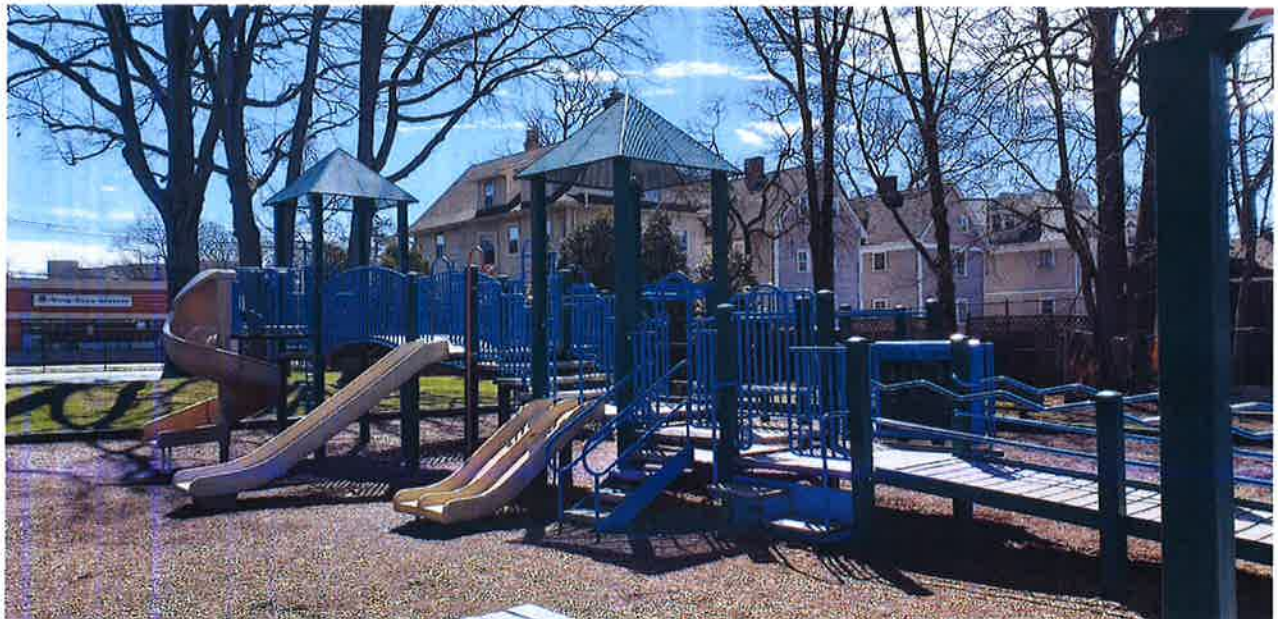
Large combination 2-5 and 5-12 age group play structure by  
Playground Environments

SCE recommends that the large existing structure from Playground Environments remain as it is in good condition and has several more years of use left. SCE would suggest adding some freestanding activity and sensory panels to this playground to help make it more inclusive. It is also recommended that additional Fibar be added to the playground area. SCE recommends completely removing the Kompan play equipment and swings and creating a larger, unified playground area with playground equipment from a reputable playground equipment manufacturer. The new structure could be custom designed to include a theme if desired and to include ramps and accessible features throughout the structure to make it truly inclusive. SCE recommends adding new swings with both typical belt and bucket seats as well as specialty seats which allow for a wide range of users. It is also recommended that a free-standing piece of equipment be installed that can offer a place of refuge for users with special sensory or social needs. This could be something like one of the tunnels, dome structure or "playhouse" structures offered by many of the playground equipment manufacturers. Since this would be a new playground structure, SCE recommends switching to a poured-in-place safety surfacing as opposed to Fibar. This will provide a surface that is more easily traversed by users in wheelchairs or with mobility limitations and avoids the need for raised plastic curbing. New seating, including both benches and picnic/game tables would be recommended adjacent to the new playground structure in an area that allows for clear sight of the equipment.

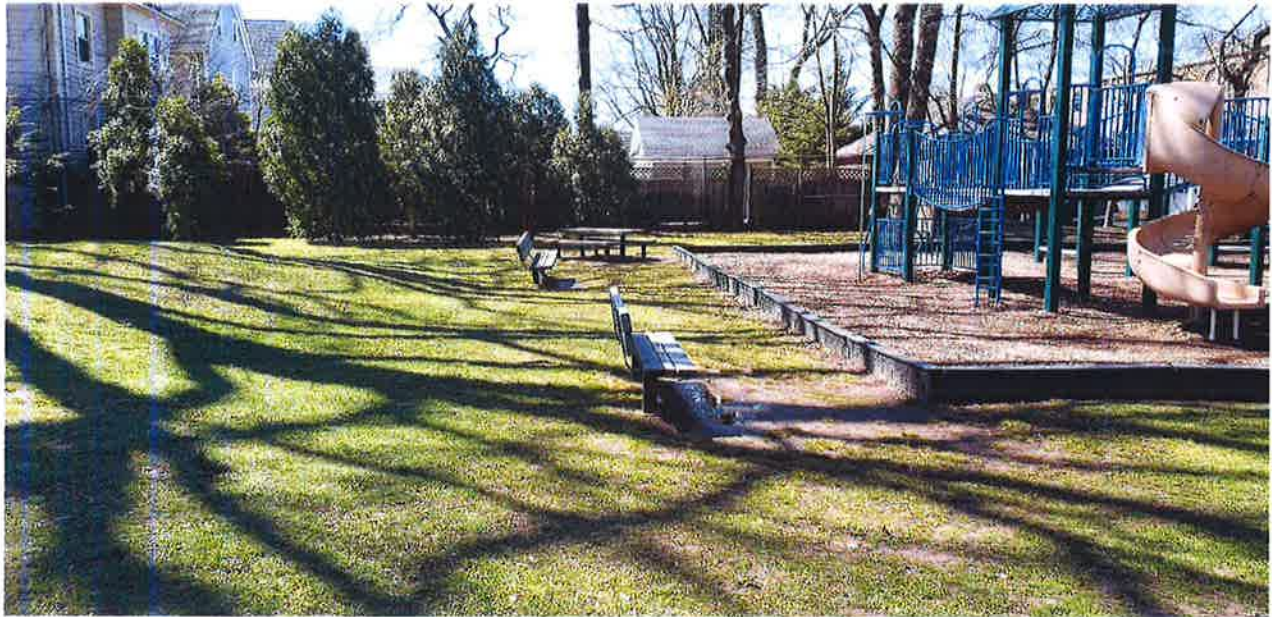
**Benches and picnic table at the larger combination play structure, additional benches are located around the perimeter of the structure.**

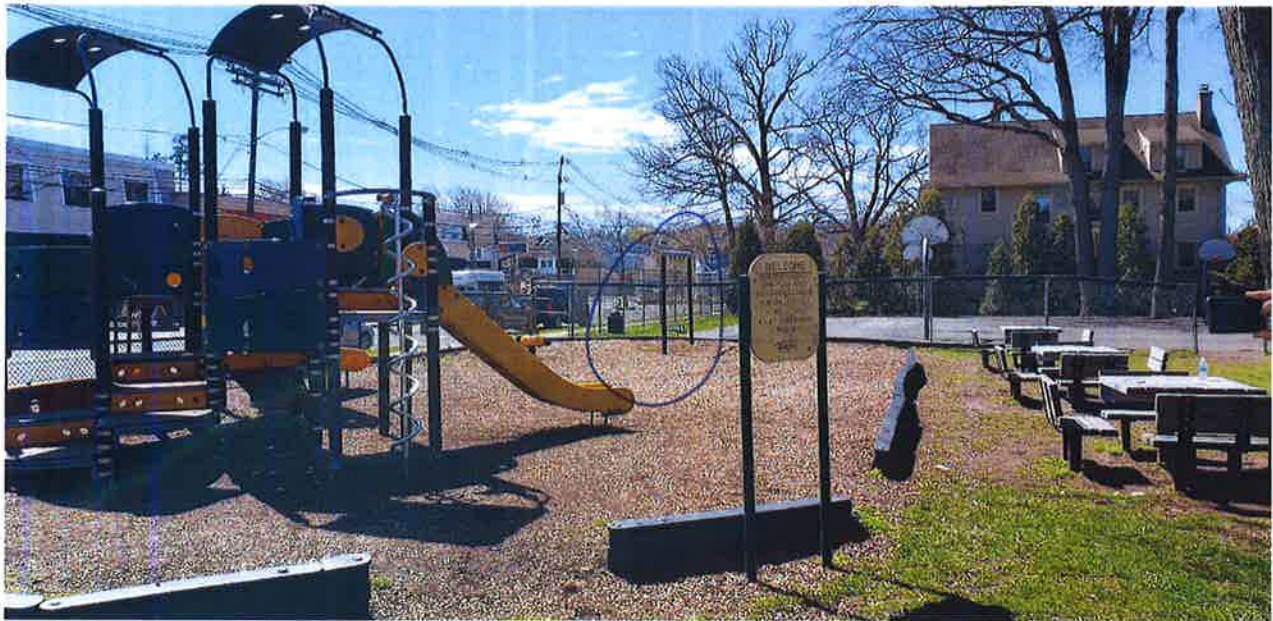
**Kompan play structure, belt swings and picnic tables located on the north side of the basketball court near Summit Avenue.**

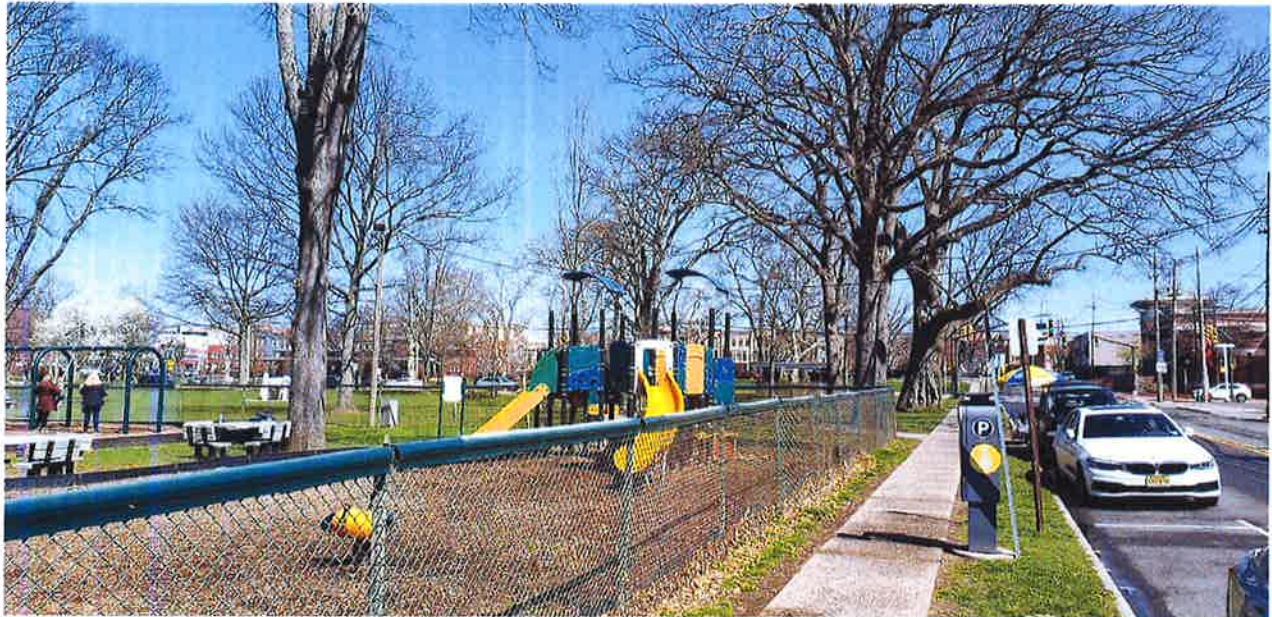
**View of the Kompan play equipment showing the proximity to the sidewalk and Summit Avenue.**

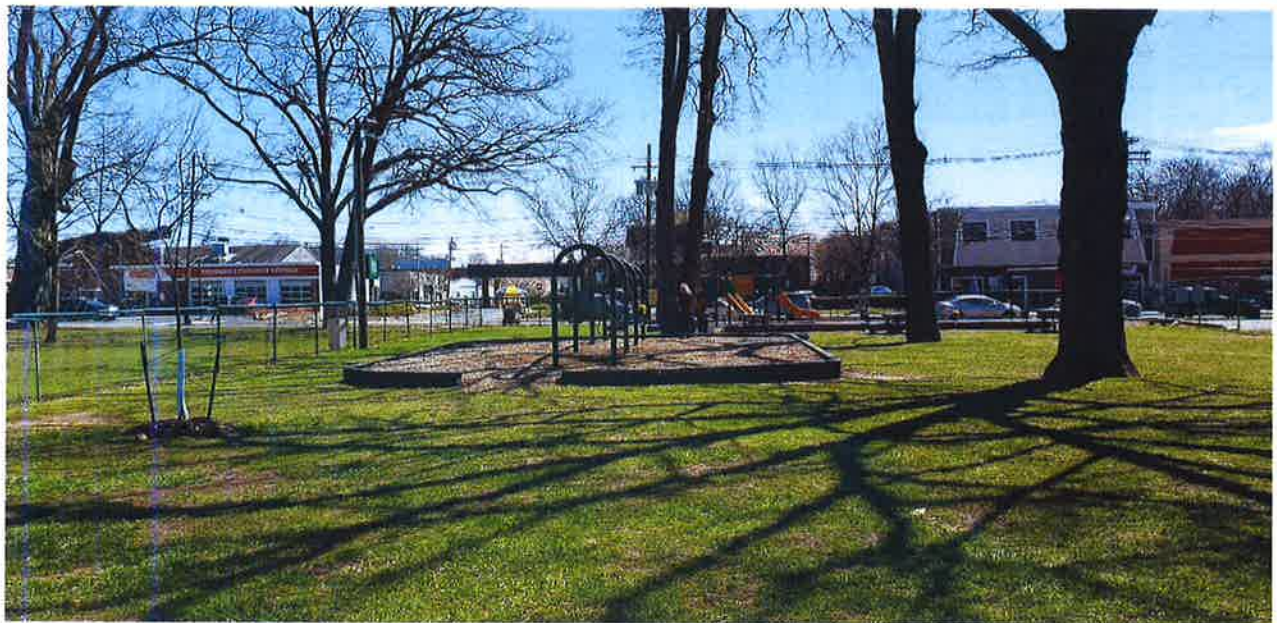
**View of the three (3) bay swing structure adjacent to the Kompan play equipment**

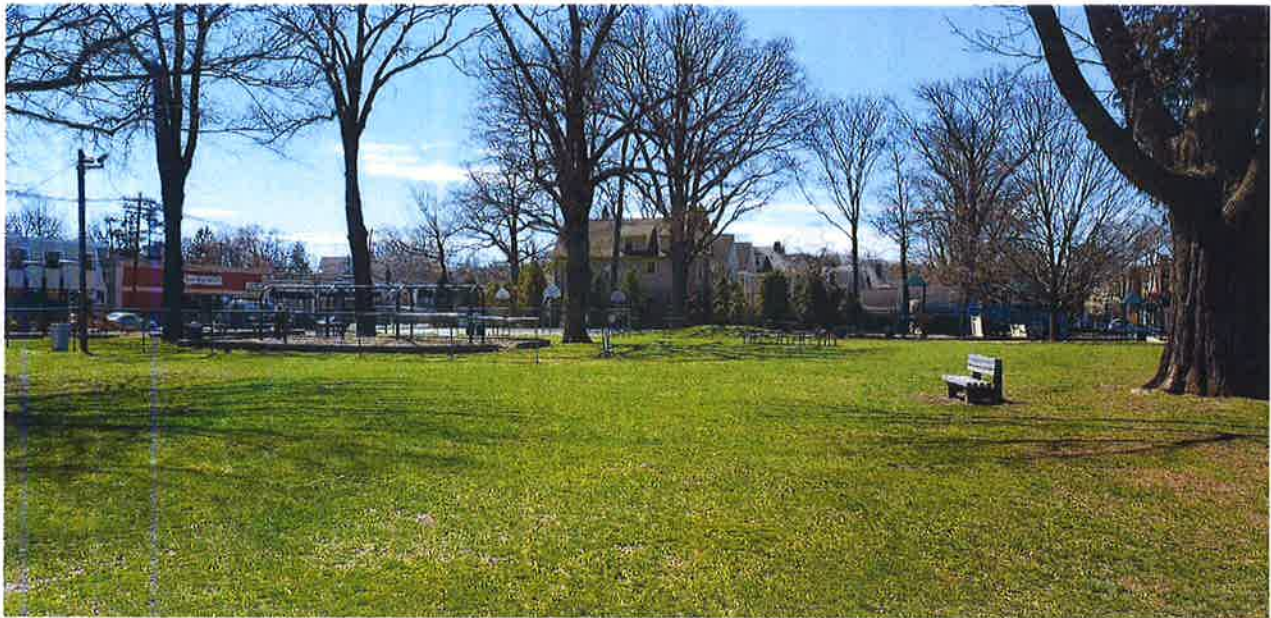
**View of the large open lawn adjacent to the playground which could be an alternative location for new equipment.**

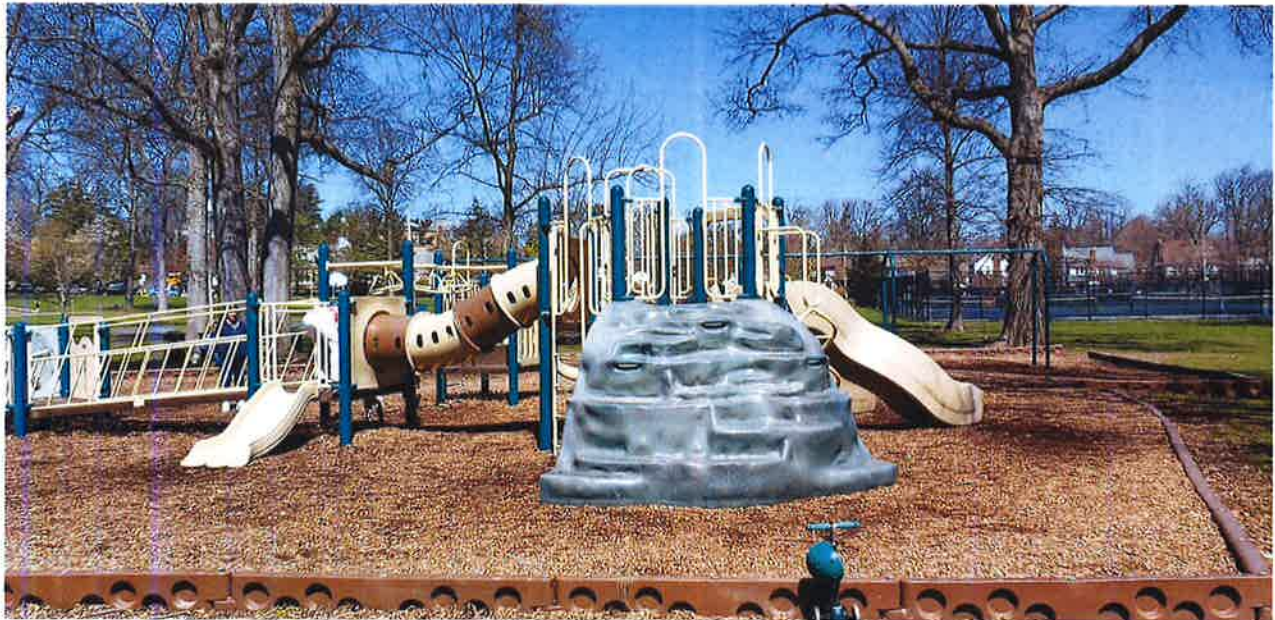
**View of the combination 2-5 and 5-12 age group playground structure from GameTime and plastic curbing.**

Although the existing playground is in relatively good condition, SCE recommends full replacement of both the 2-5 structure and 5-12 structure with newer equipment as this equipment is nearing its typical use lifespan. To save on costs the existing framework for the swings could be salvaged and some of the seats could be swapped out for an accessible swing seat to improve inclusivity. SCE recommends the City replace the existing play structures with new separate play structures for the 2-5 age group and the 5-12 age group. SCE would recommend using products that are manufactured by a reputable playground manufacturer and recommends that these structures, especially the larger 5-12 age unit be designed with ramps and features which improve accessibility and inclusivity on the unit. Since this would be a nearly full replacement, SCE recommends switching from Fibar to poured in place rubber safety surfacing with a flush concrete curb. There is adequate seating adjacent to the playground, however much of it is oriented away from the playground. SCE recommends installing additional benches to match the existing on site around the perimeter of the playground with clear line of site to the play equipment.

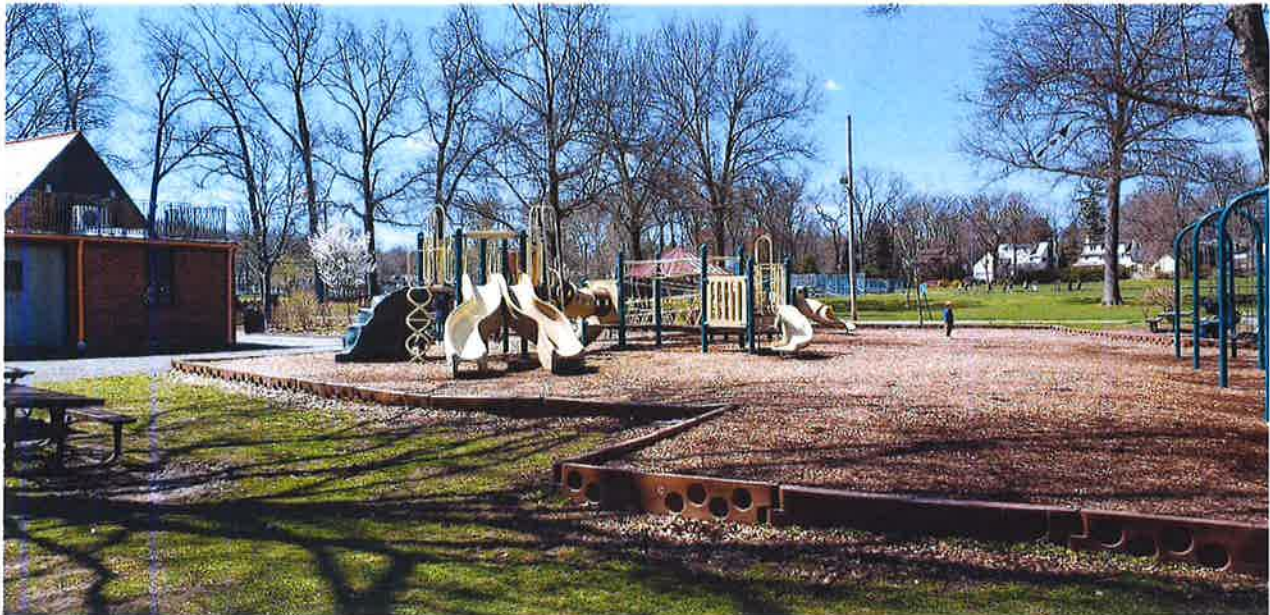
**Alternative view of the combination play structure with three (3) bay swing structure visible on the right.**

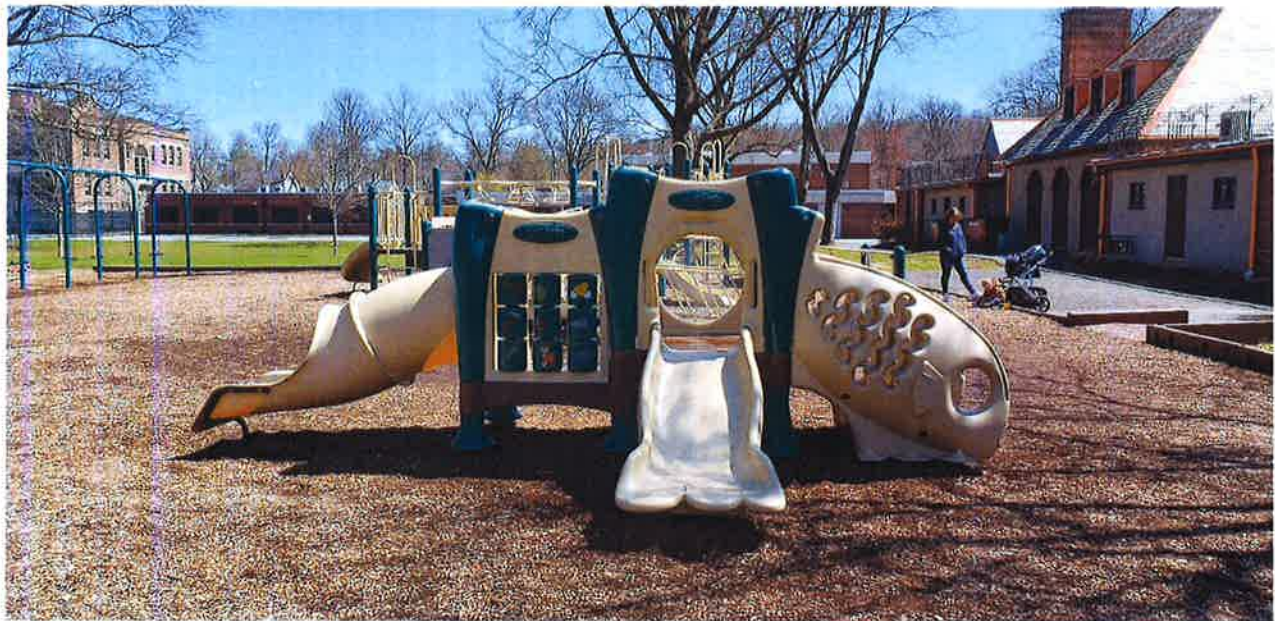
**View of the small 2-5 year old play structure by GameTime.**

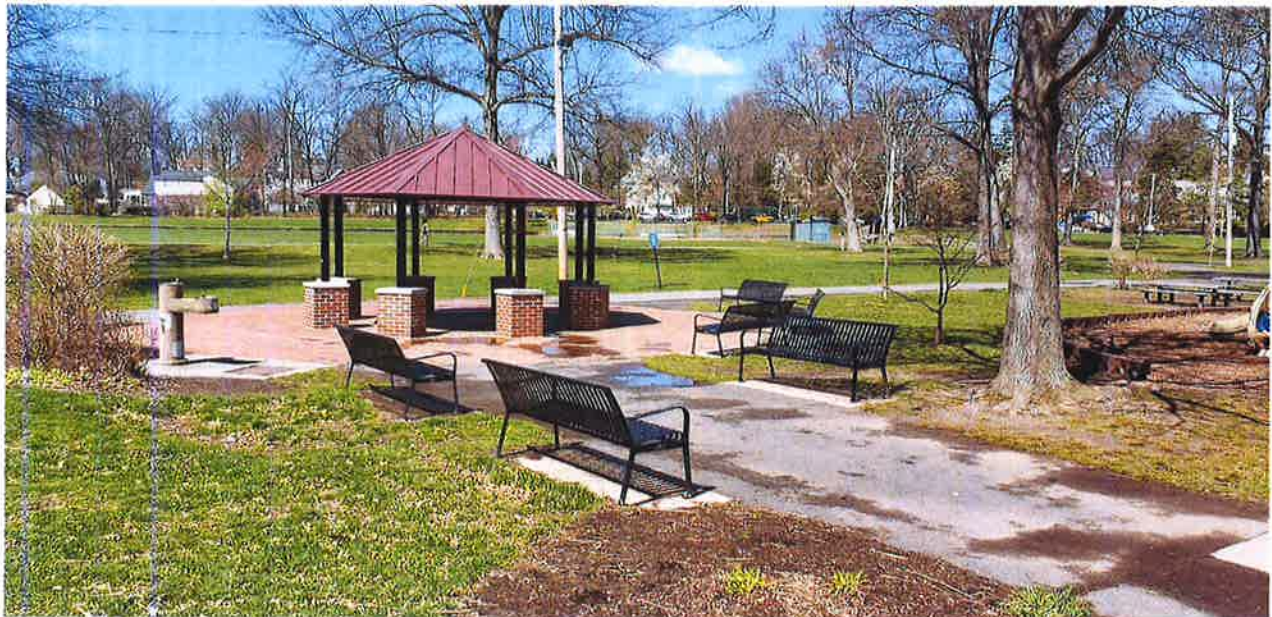
**View of the small pavilion, drinking fountain and seating area directly adjacent to the playground area.**

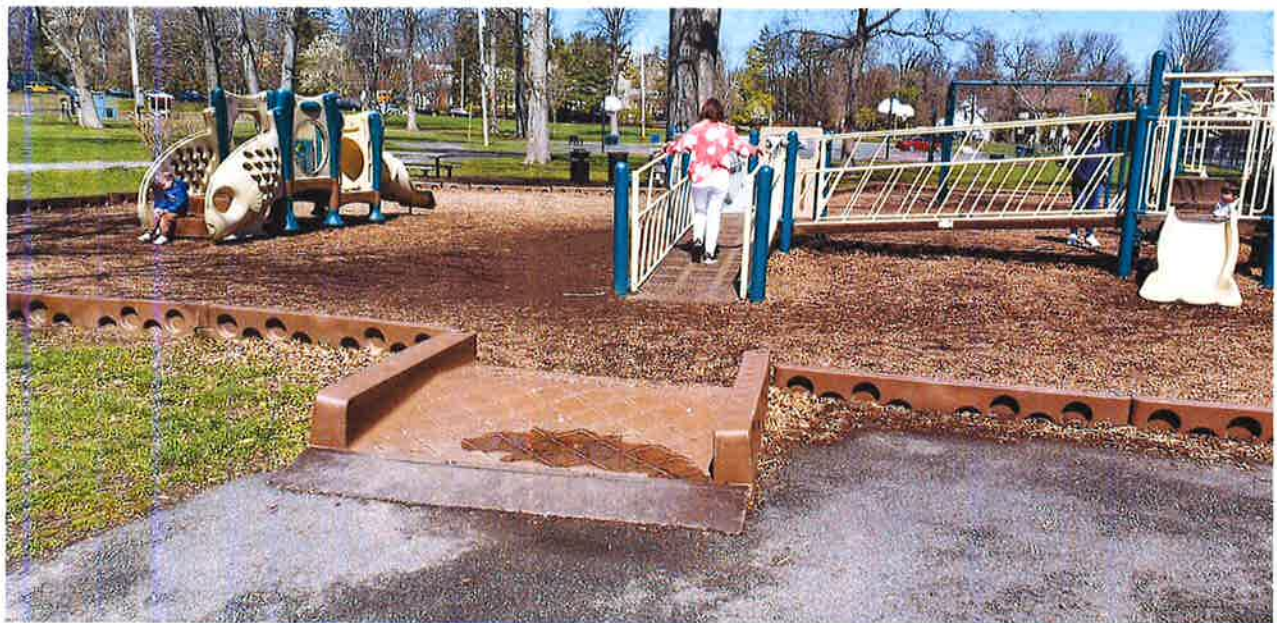
**View of the plastic transition piece from the asphalt pavement walkway to the fibar surfacing at the playground entrance located behind the park office building.**

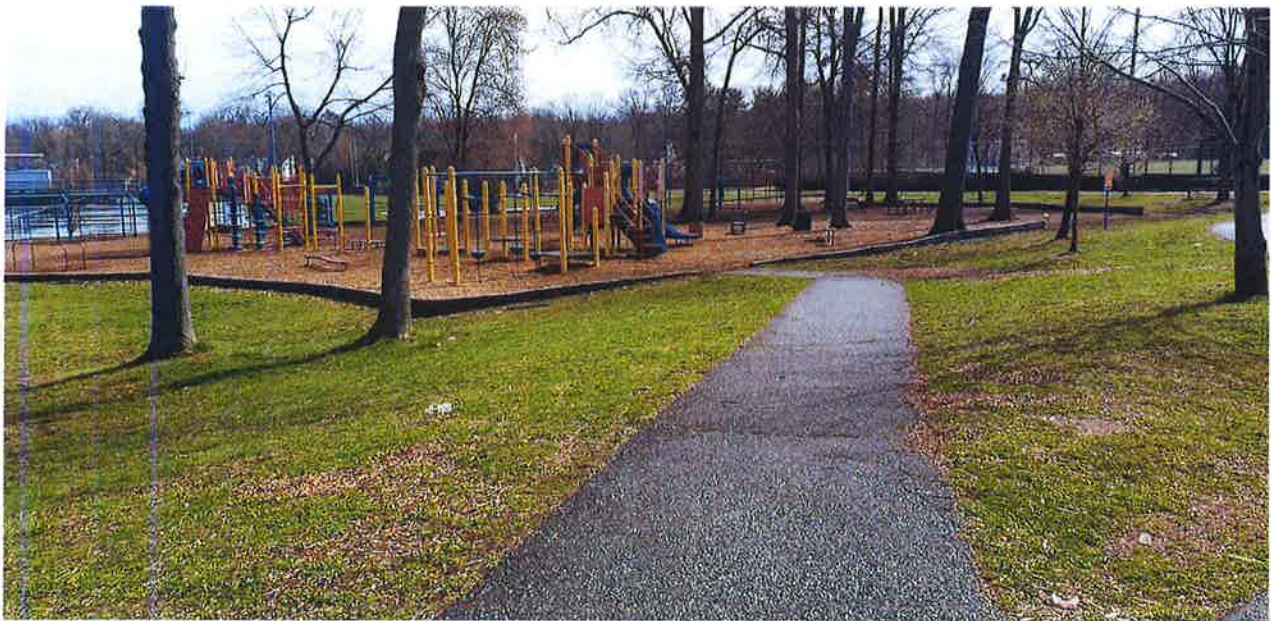
park is accessible from a paved asphalt pathway from the adjacent school parking lot and through various cut-outs in the plastic curbing. The slope of the pathway from the parking lot may be out of tolerance for ADA compliance and may need to be regraded. The playground features a variety of play equipment, but is geared towards the 5-12 year old age group. There is one large, sprawling play structure which features several slides linked by various overhead climbing and balance components. Overall, this large play structure manufactured by GameTime is in poor to good condition with some climbing pieces missing components, fading on the red plastic pieces and some corrosion observed on some of the hardware as well as missing hardware. In addition to the large play structure, there are three (3) sets of single bay swings with a total of four (4) belt swings and two (2) bucket swings. Additional free-standing equipment includes a small zip line (metal track), serpentine overhead bars, pull-up bars and a large net climber. The swings and freestanding units are in poor to good condition.

**View of the asphalt pavement access pathway leading from the parking lot to the playground area.**

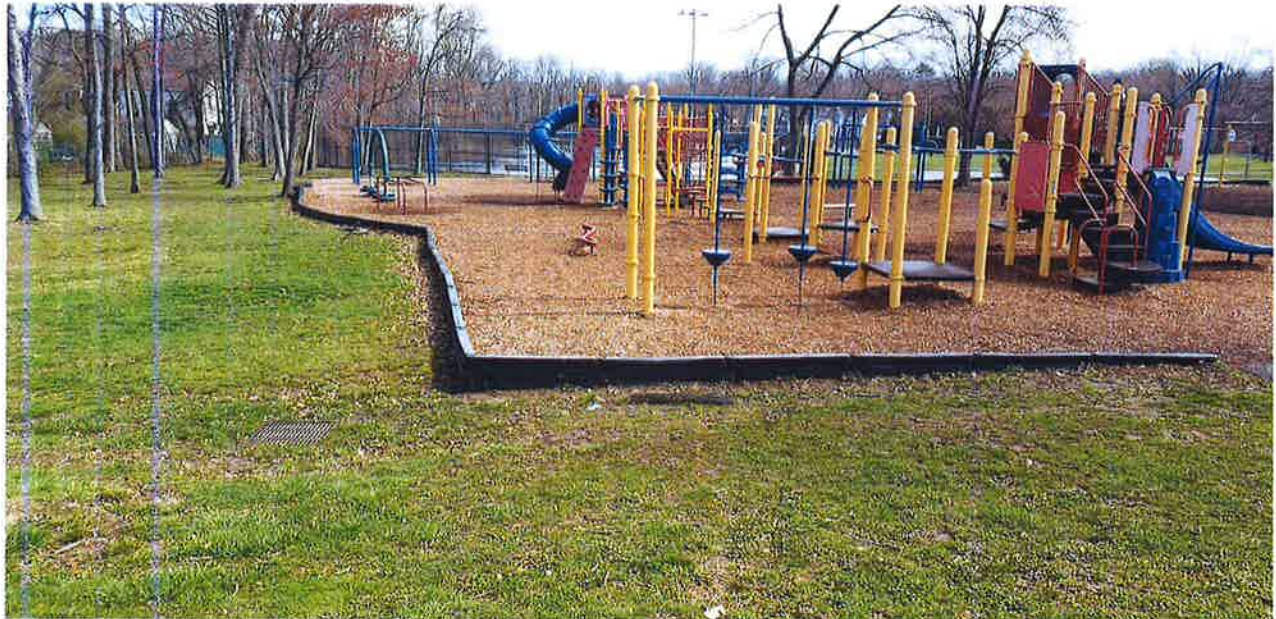
**View of the large 5-12 play structure, fading of the red and blue components are visible.**

Based on the poor to fair condition of the existing playground equipment, SCE recommends full replacement. Since this is a large area to work with, SCE would recommend one large structure with combined areas and activities for both 2-5 and the 5-12 age groups. This large structure should be custom designed to include ramps, slides and other activities which can be accessed and used by playground visitors of all abilities. SCE also recommends the addition of various free-standing equipment throughout the area that can be used by both age groups. SCE recommends a variety of freestanding equipment that engages users on multiple levels including net climbers, overhead bars, rotating or swinging equipment and

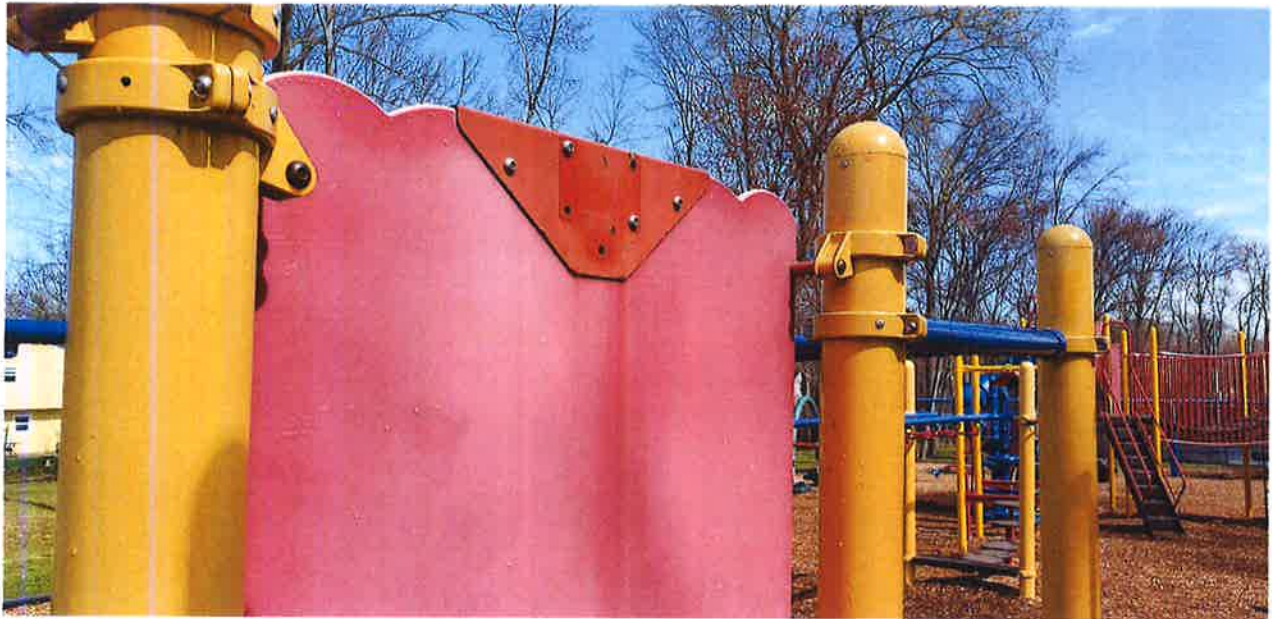
**Example image of the fading typical on the playground structure, image also shows some missing hardware on the panel piece.**

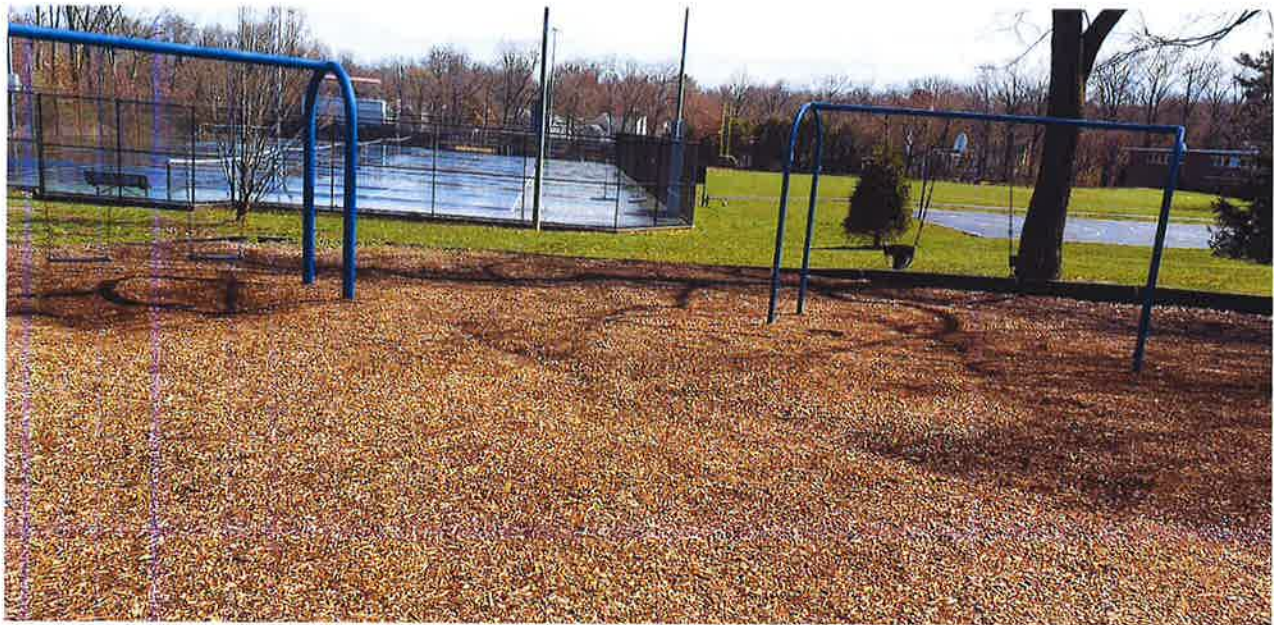
**Two of the three existing swing set structures. The unit on the left is set up with three bays, however the central bay is missing swings.**

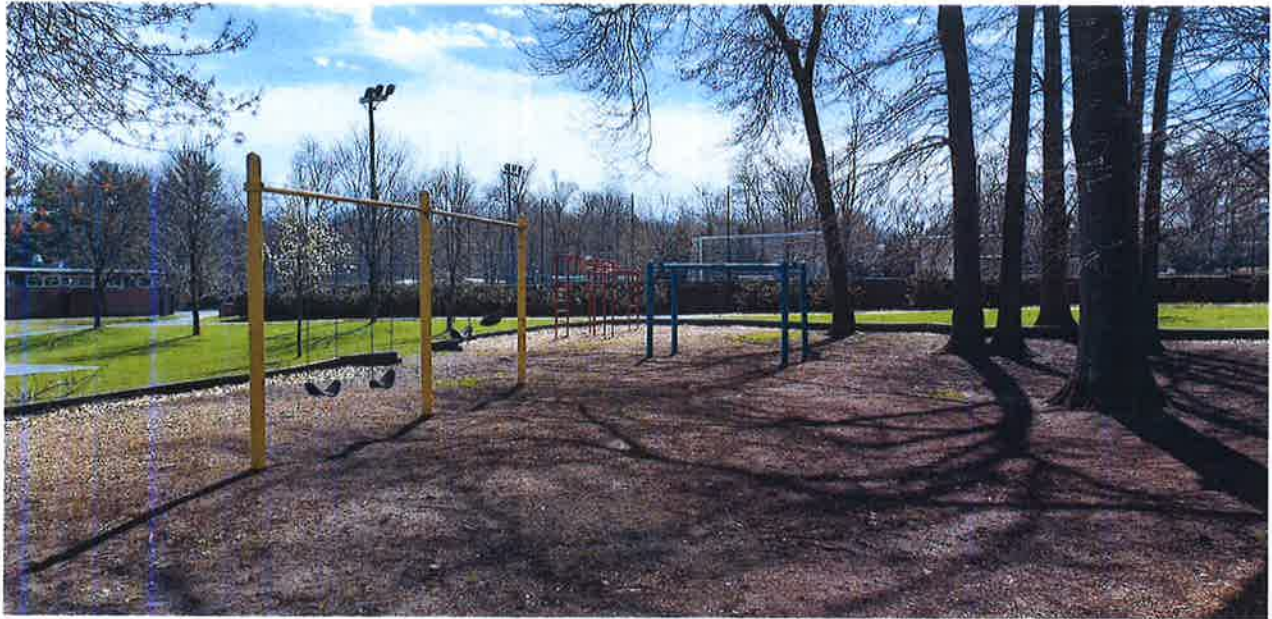
**View of the third swing structure with four (4) belt swings, zip-line type equipment and serpentine overhead bar structure.**

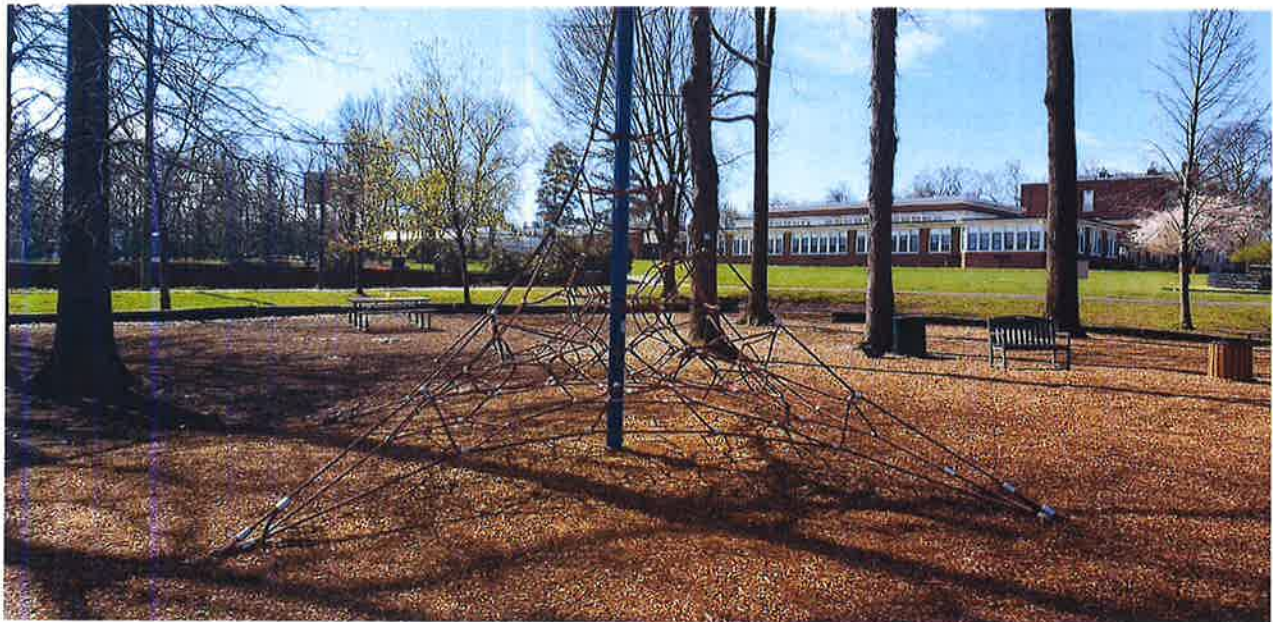
**View of the net climber located in the center of the playground area, bench, picnic table and waste receptacles are visible and typical of those found throughout the playground area.**

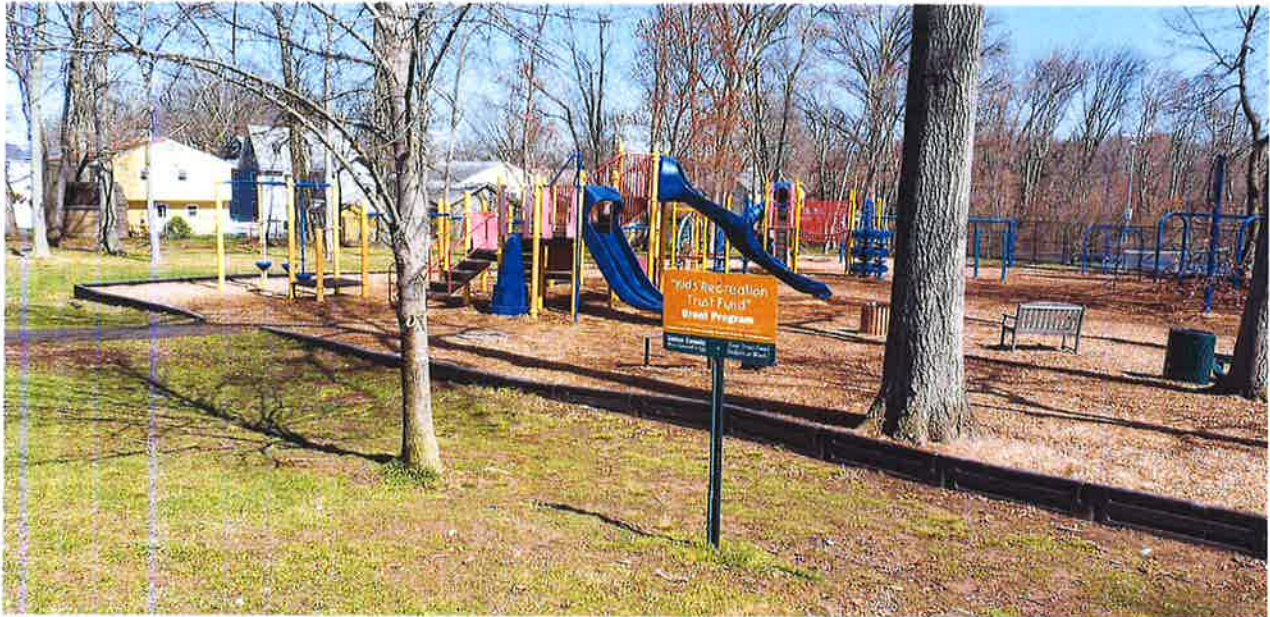
**View of Grant program signage with large 5-12 play structure visible in the background**

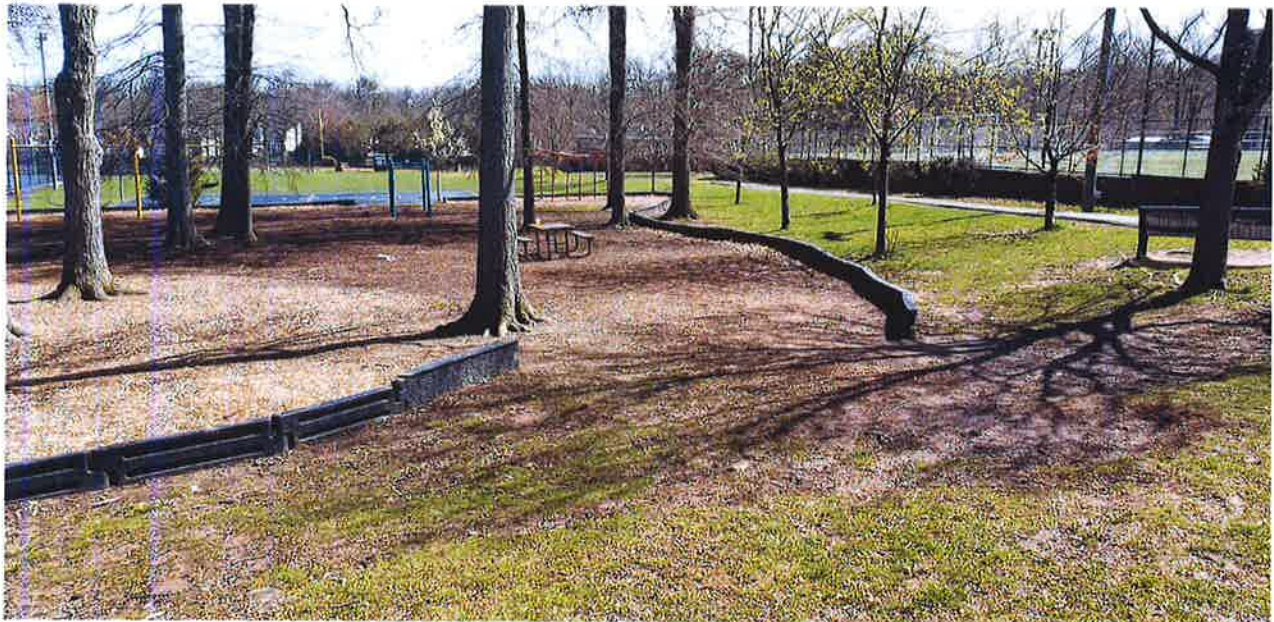
**Break in plastic curbing for maintenance vehicle access into the playground area.**

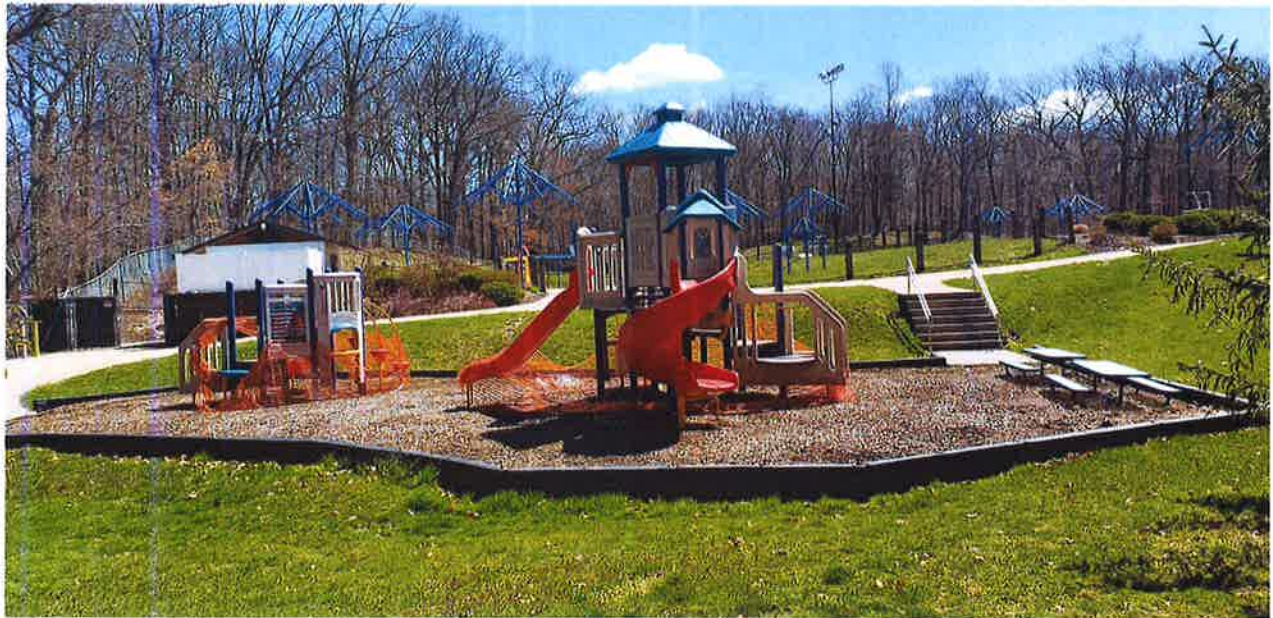
Overall view of the playground area at the Aquatic Center; 2-5 age group equipment on the left and 5-12 age group equipment on the right.

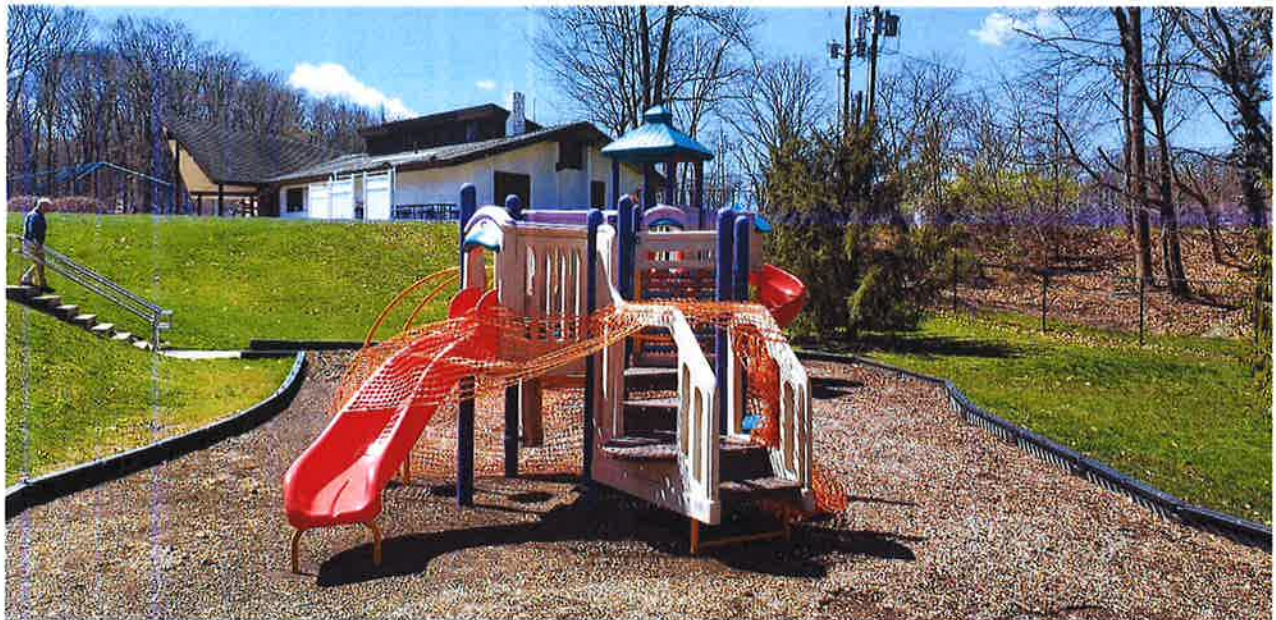
View of the 2-5 age group equipment; orange temporary fencing was to restrict access during a recent event.

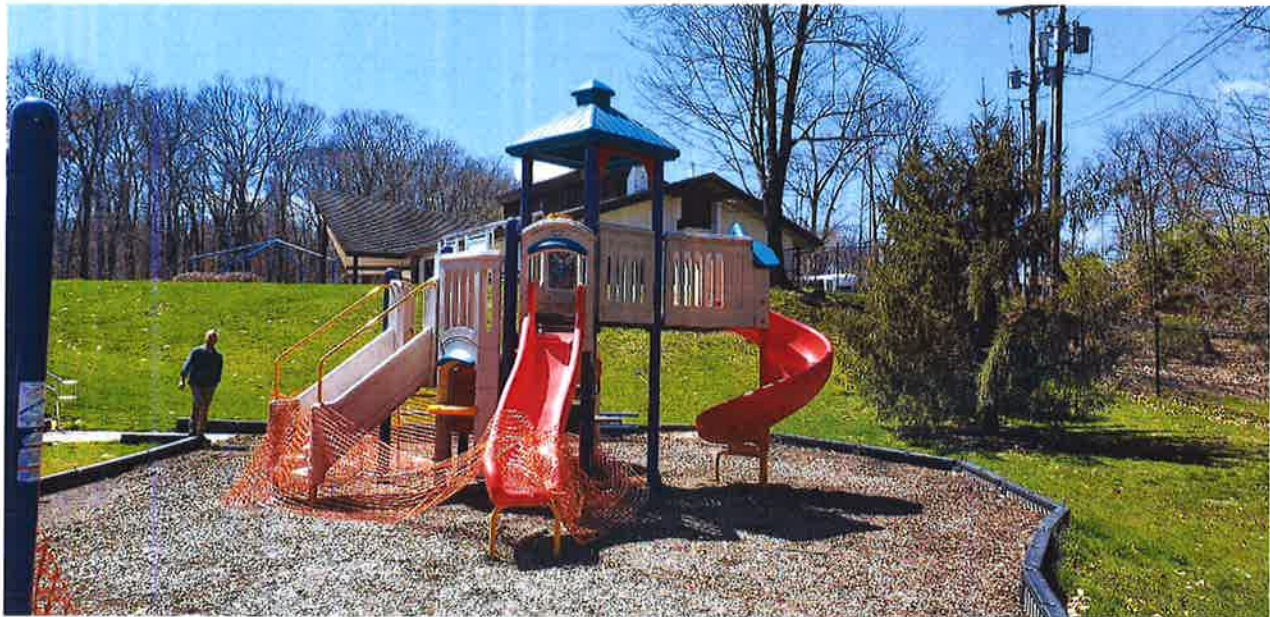
**View of the larger 5-12 age group play equipment; the equipment is only 2-3 years old and is in good condition.**

Since this equipment is in good condition and relatively new, SCE recommends the equipment, plastic curbing and fibar to remain in place. The existing area could be supplemented with a few pieces of free-standing equipment which provide more opportunities for social and cognitive engagement such as the sensory play center by Landscape Structures. This piece of equipment has various auditory and tactile elements which encourage children to explore different, shapes, textures and sounds and could be used by multiple children simultaneously. This could also be a good location for a swing such as the oodle swing by Landscape Structures or similar product offered by many of the leading playground equipment manufacturers. This type of swing does not take up as large of a footprint as a traditional swing and allows for four to six children to use at once. This site could also be a good location to install outdoor musical equipment. SCE recommends the fibar surfacing remain in place and be refreshed with new material to ensure adequate fall protection. The plastic curbing should be adjusted to address some of the drainage issues and all the pins should be installed flush with the top of the curbing. The Fibar and plastic curbing could be replaced with flush concrete curbs and poured-in-place rubber safety surfacing once the larger play structures have reached the end of their typical lifespan and are ready for full replacement. SCE also recommends installing one or two benches around the perimeter of this playground to provide a resting place for parents in addition to the picnic table.

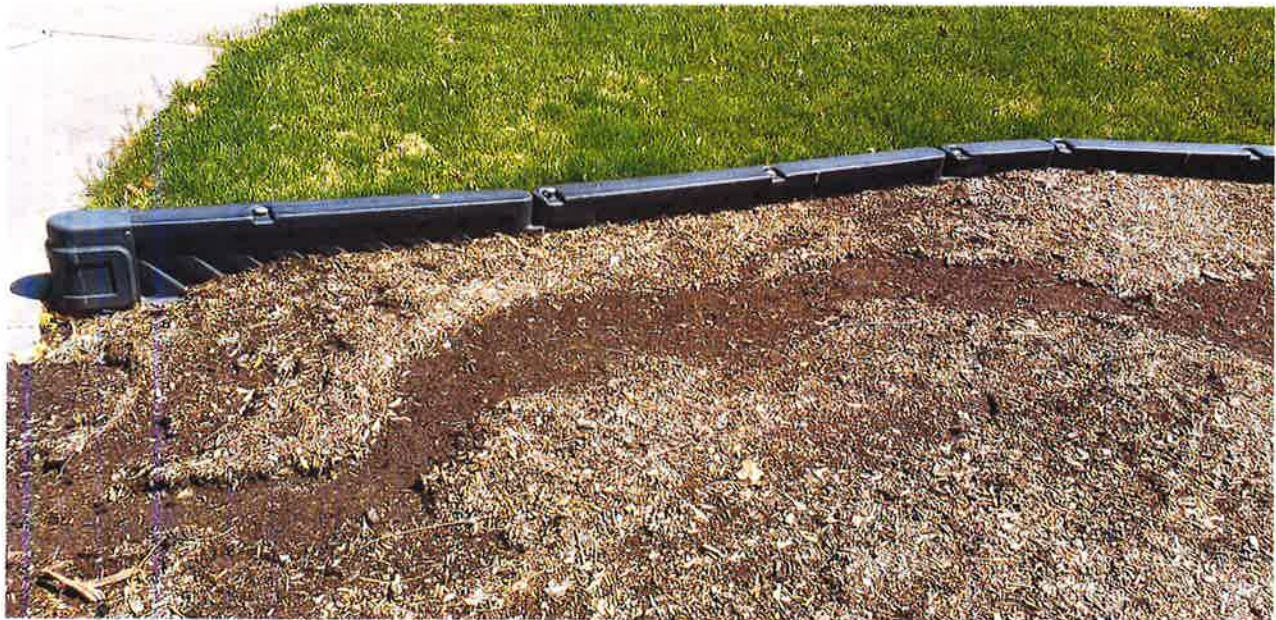
**Drainage issues near the entrance to the playground area from the sidewalk. Runoff from the adjacent slope is eroding the Fibar surfacing.**

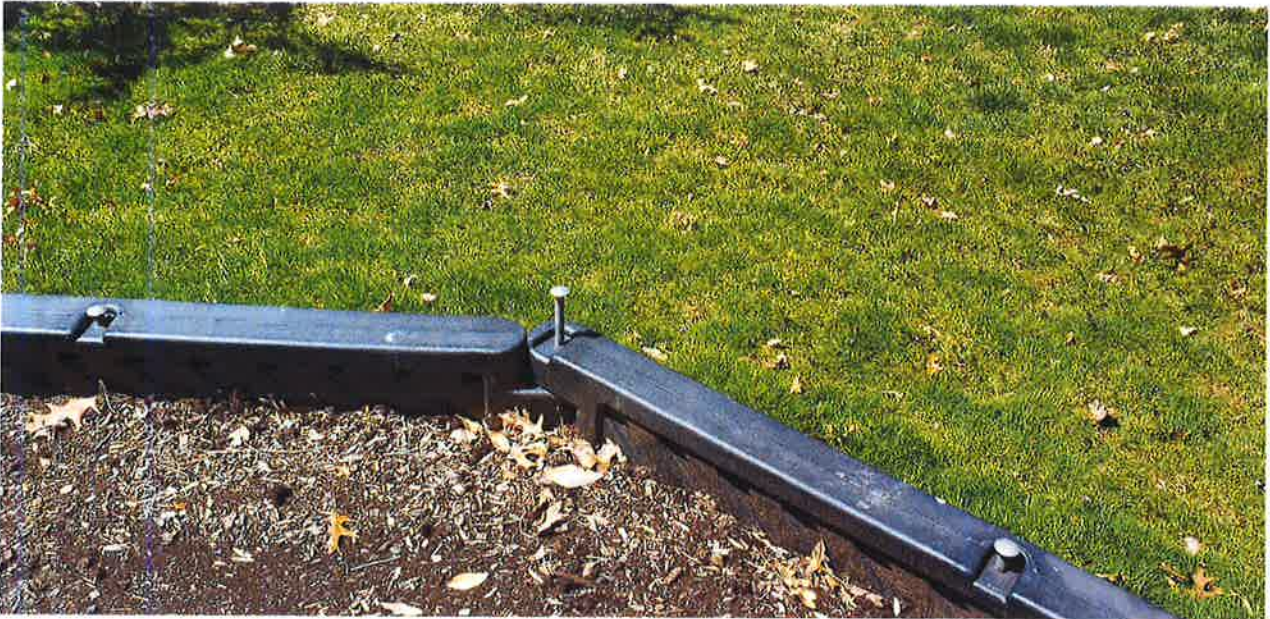
Surfacing consists of Fibar and needs replenishment to meet fall height protection requirements. Fibar is held in place by black plastic curbing, which is in good condition, however several of the pins which hold the curbing in place and interlock the segments are protruding above the curbing and are a tripping hazard. The curbing has also created some drainage issues by blocking water coming off the slope on the east side of the walkway and causing it to pond on the east side of the playground. Seating in this area is limited to two (2) picnic tables within the playground limits, however there are additional picnic tables and benches throughout the pool complex. No site lighting, trash receptacles or playground signage were observed within the playground area. In addition, there is no fencing around the playground area apart from the perimeter fencing for the complex which is located on the north and west sides of the playground.

**Stakes from the plastic curbing are protruding in several locations and are tripping hazards**
