# **PLAYGROUND ASSESSMENT FOR**

## **THE CITY OF SUMMIT**

**CITY OF SUMMIT, COUNTY OF UNION, STATE OF NEW JERSEY**

**June 2022**

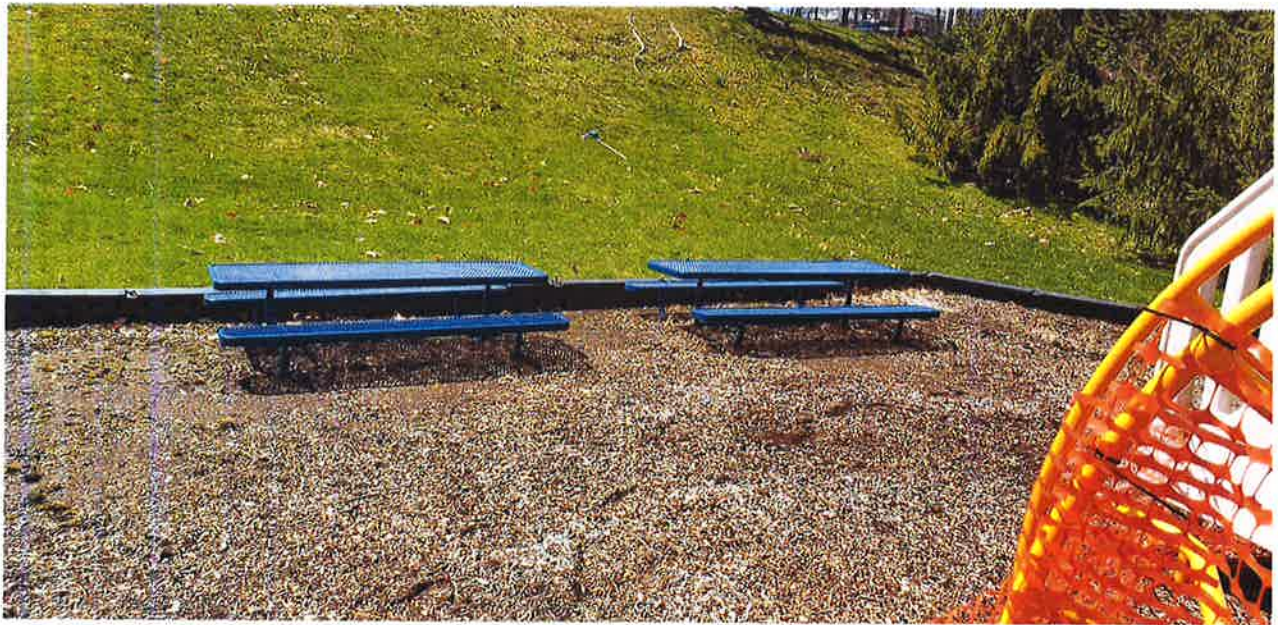
**Two (2) picnic tables located within the playground area provide seating, additional tables and benches are located throughout the Aquatic Center Complex.**
