# **PLAYGROUND ASSESSMENT FOR**

## **THE CITY OF SUMMIT**

**CITY OF SUMMIT, COUNTY OF UNION, STATE OF NEW JERSEY**

**June 2022**

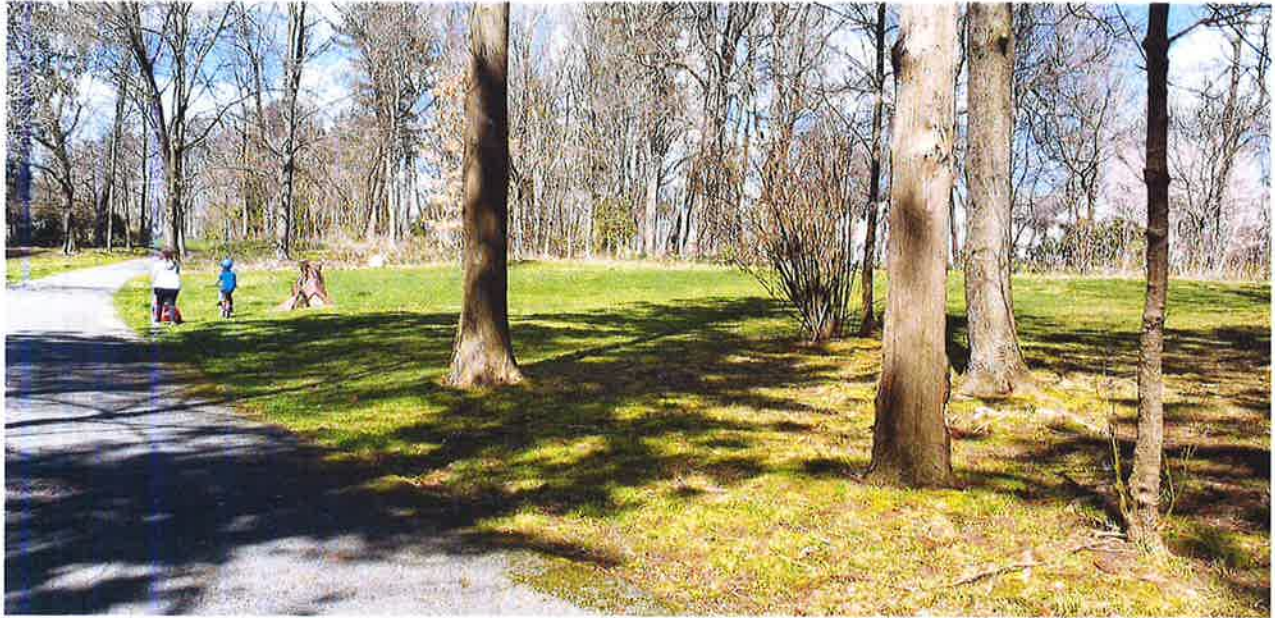
**View of the existing asphalt pavement access drive which connects Wilson Park to Springfield Avenue.**

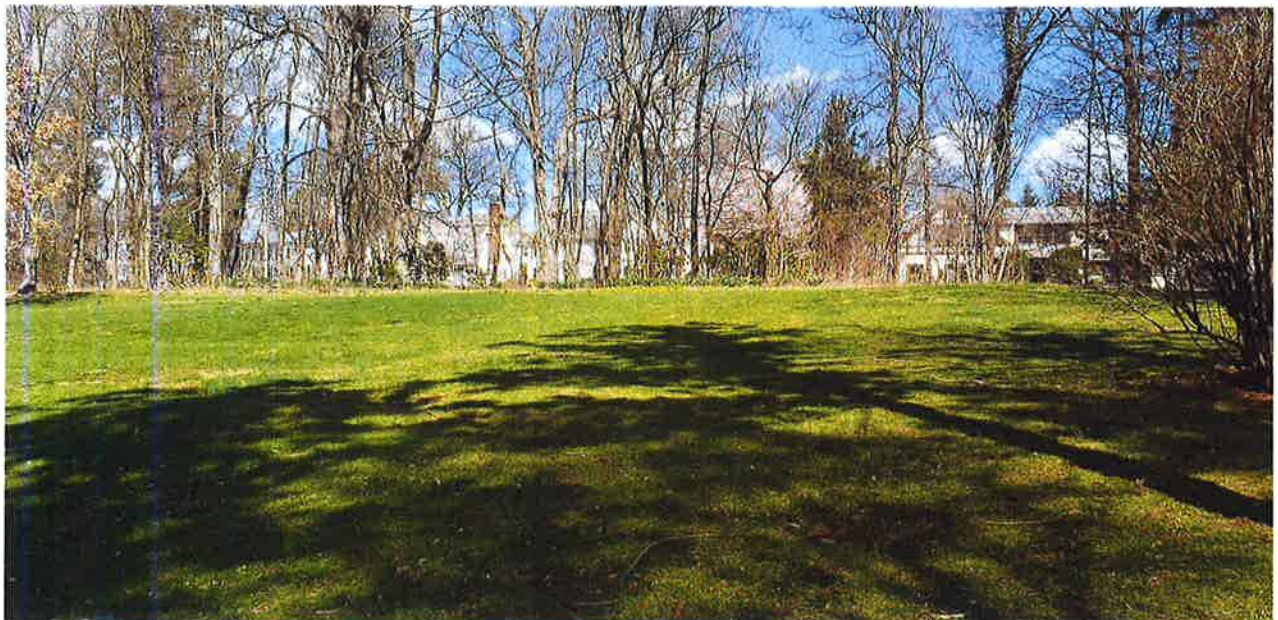
**Large open lawn area to the east of the existing asphalt pavement access drive.**

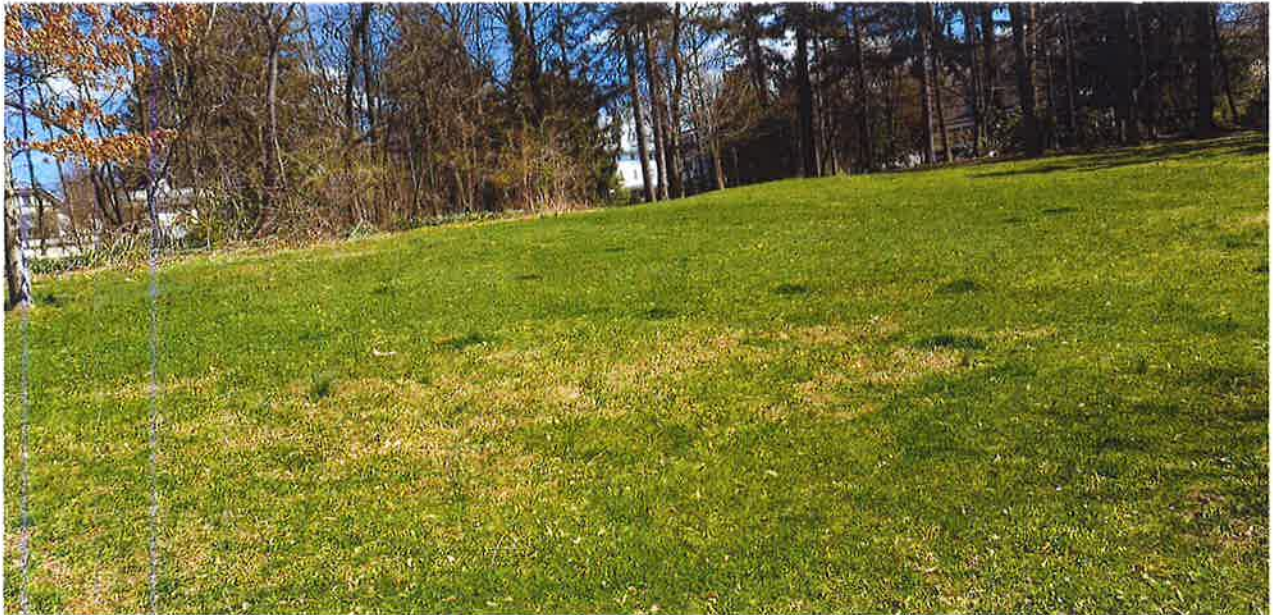
**Additional view of the large open lawn area located on the east side of the existing asphalt pavement access drive.**

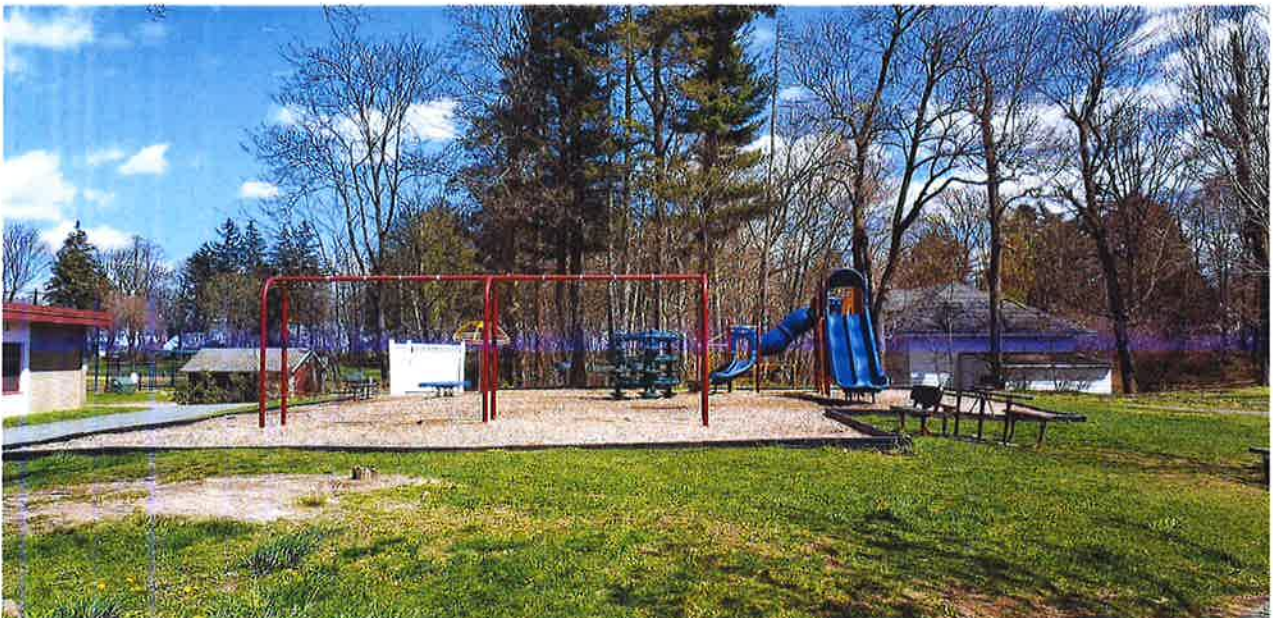
It should be noted that a playground currently exists just south of the school building at Wilson Park. The equipment in this playground was observed to be manufactured by GameTime and looks to have been installed within the past year or two based

on its condition. The structure is sized for the 5-12 year old age group and has several slides and climbing features. This playground also features a two (2) bay swing set with two (2) belt swings and two (2) bucket swings.

**The nearby Wilson playground at Wilson Park. This playground is connected by the existing asphalt pavement access drive and is located slightly north and west of the art park area.**

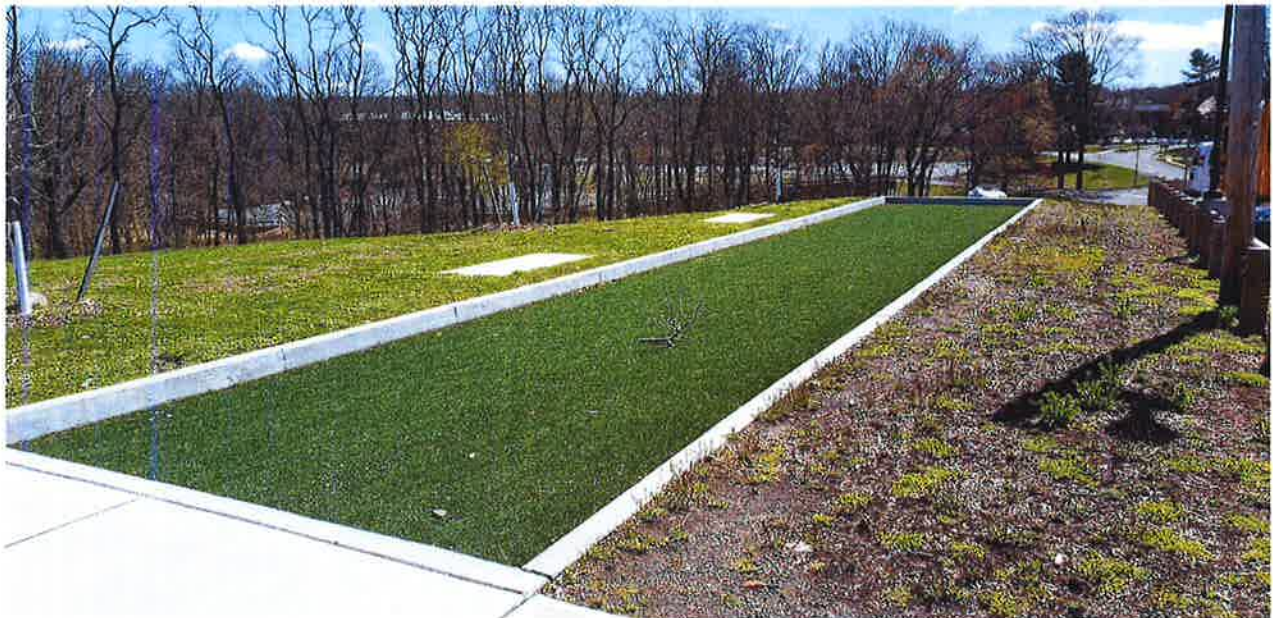
Existing bocci ball court off the eastern parking lot at the community center, the lawn area to the left is one of three (3) potential locations for a future playground at the community center.

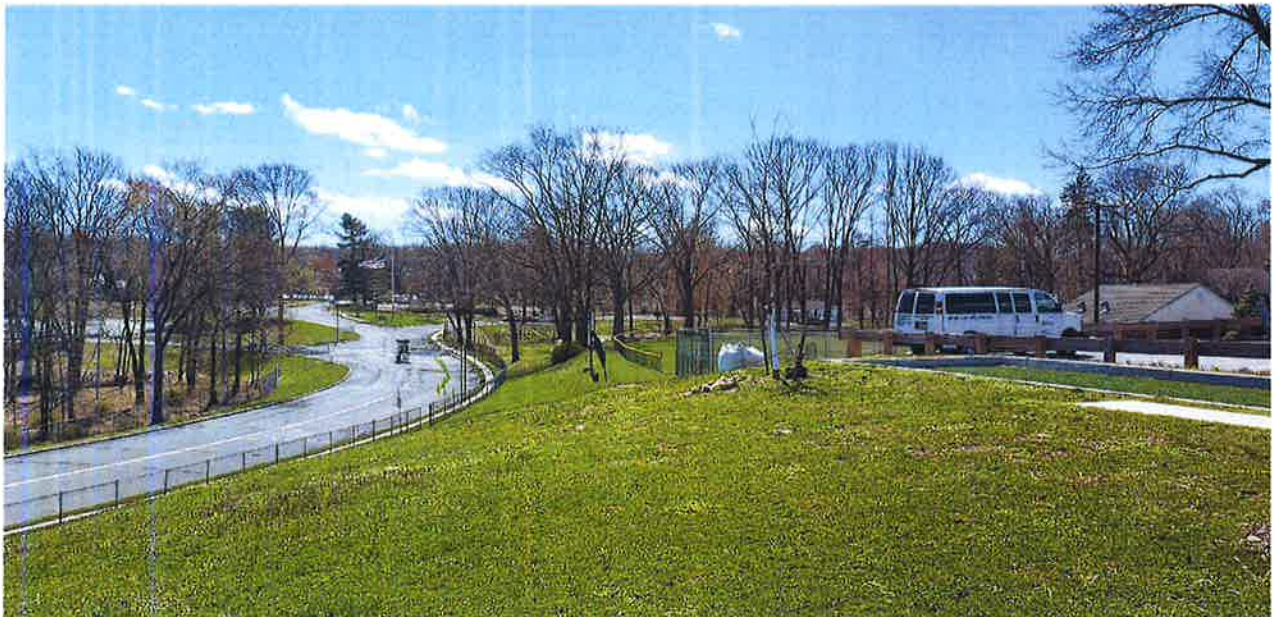
Looking south at the open lawn area near the existing bocci ball courts, while this area is large and would not require significant clearing, retaining walls would be needed to terrace the slope and create useable space.

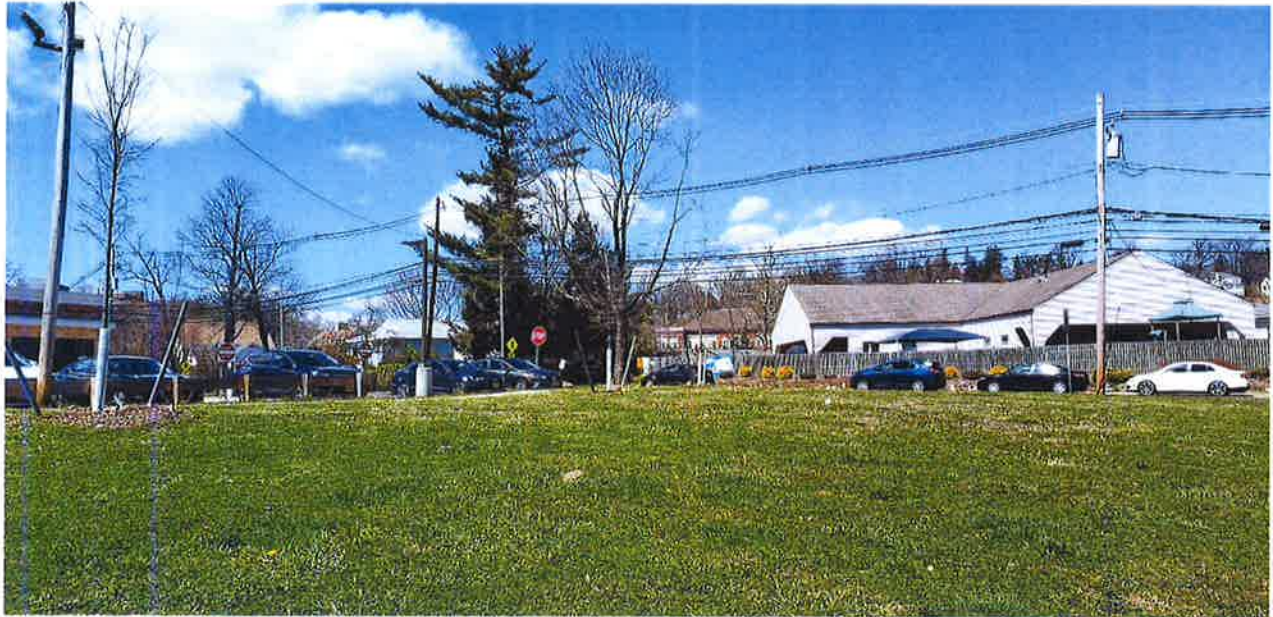
**View looking north at the open lawn area adjacent to the existing bocci ball courts. Morris Avenue is visible in the background and fencing would be required around a playground in this area for safety.**

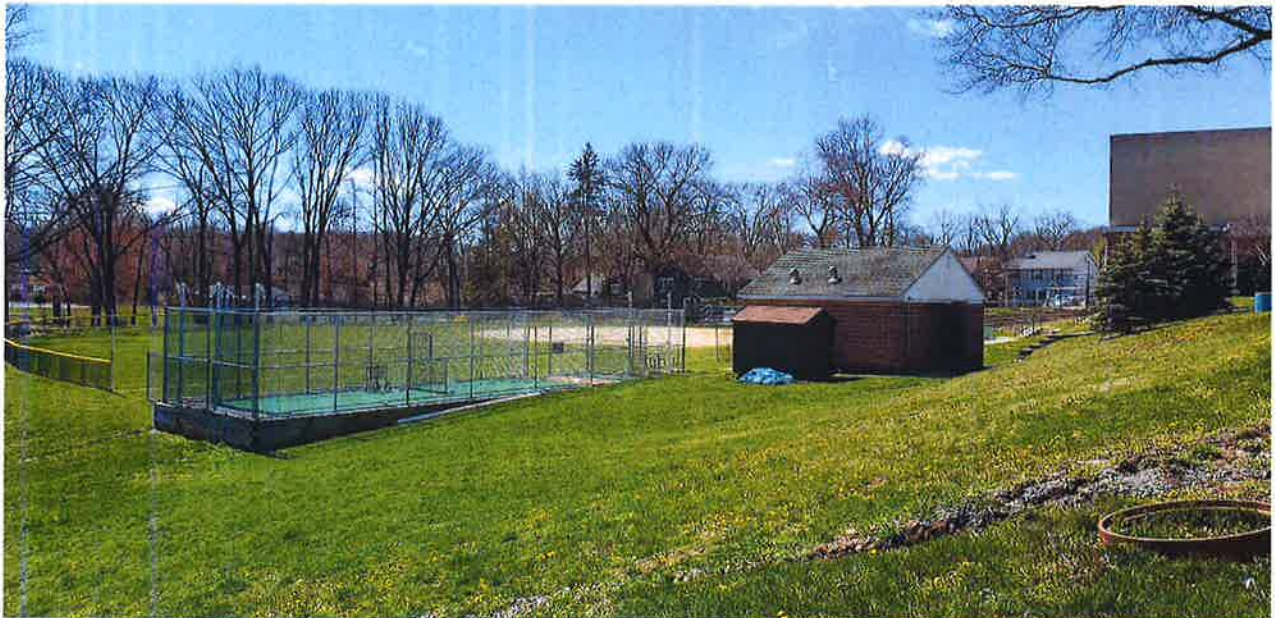
**View of the second potential playground location at the Community Center. This area is located off the southeast corner of the Community Center and provides a relatively flat, open area. There is an existing retaining wall partially visible in the photo which could be extended east to create additional space for a playground.**

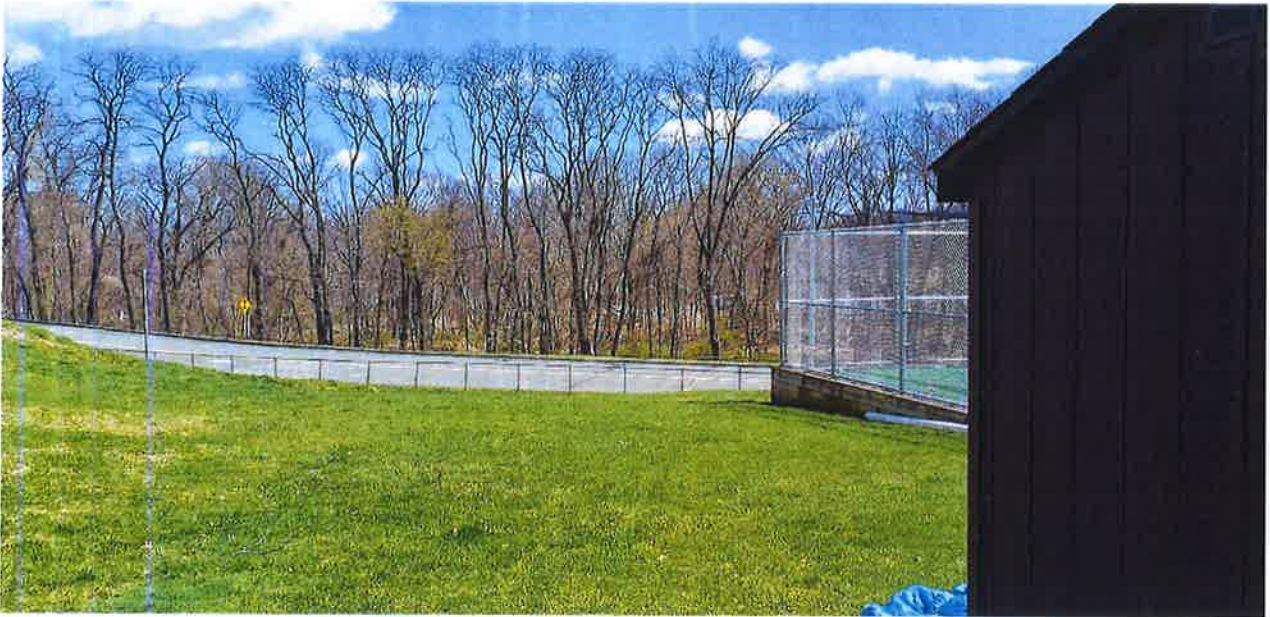
**View of the second potential playground location looking east from the existing restroom building.**

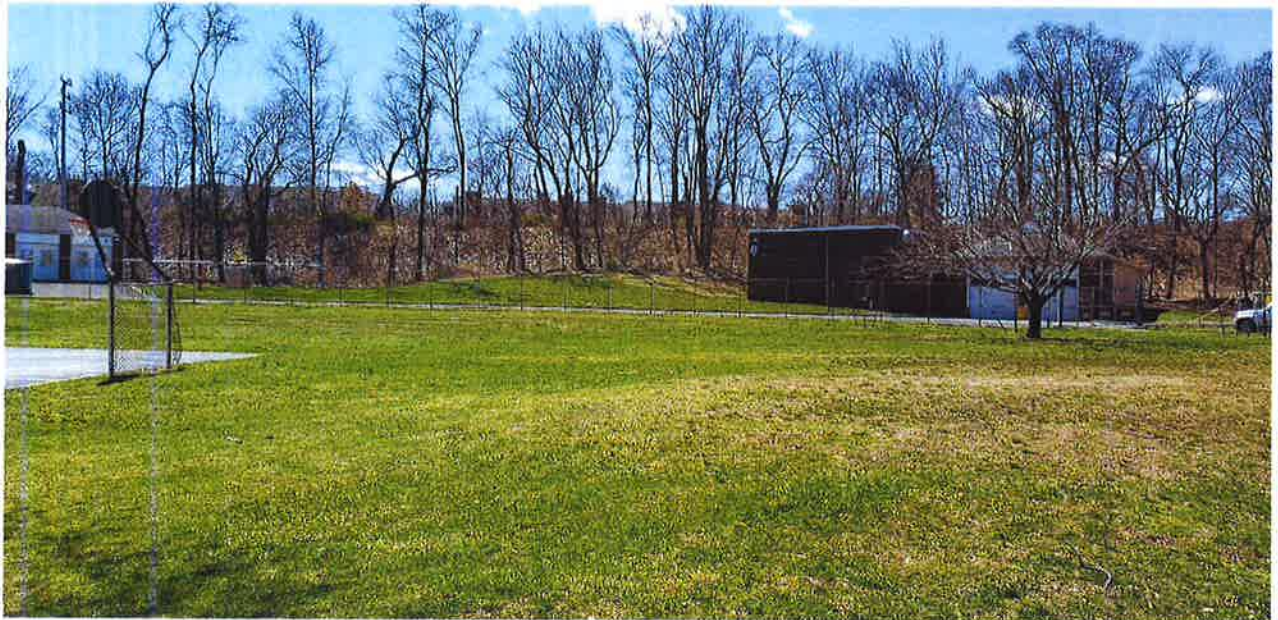
The third potential playground location at the Community Center is further south in the Edison Recreation Center. Currently there is a basketball court and "pocket forest" installed as a community engagement piece with Bristol Meyers Squibb. This area also has ample, open lawn area which could accommodate new playground equipment. An accessible pathway would need to be constructed from Morris Court to the new playground if it were constructed in this area. Again, fencing would not be as crucial as Morris Court is a dead-end street with minimal vehicular activity observed during the site visit.

**View of the third potential playground location south of the existing little league field. This area is located within the existing Edison Recreation Area and provides flat open areas for potential playgrounds.**

Of the three areas mentioned above, SCE recommends constructing a new playground at the community center within the Edison Recreation Center area, south of the little league field. This location is ideal for new construction given it's relatively flat, open terrain and access from Morris Court. SCE recommends new 2-5 and 5-12 age group structures here that could either be combined or standalone structures. Portions of the structures could be ramped to increase accessibility and inclusivity. SCE also recommends installing swings at this location with at least two belt swings, two bucket swings and one accessible seat swing. Some amount of paving would be required to provide access from Morris court to the playground area and could be constructed from a variety of material. SCE recommends that new playground areas be surfaced with poured-in-place rubber safety surfacing contained by a flush concrete curb. Seating such as benches and game/picnic tables should be installed in this area to provide places to gather and rest and to provide parents and guardians with a clear line of site to the playground equipment. The City may want to consider installing low, decorative fencing on the Morris Court side of the playground to help deter children from running out into the street, however this is not entirely necessary as Morris Court is a dead street and does not appear to have heavy traffic volume.

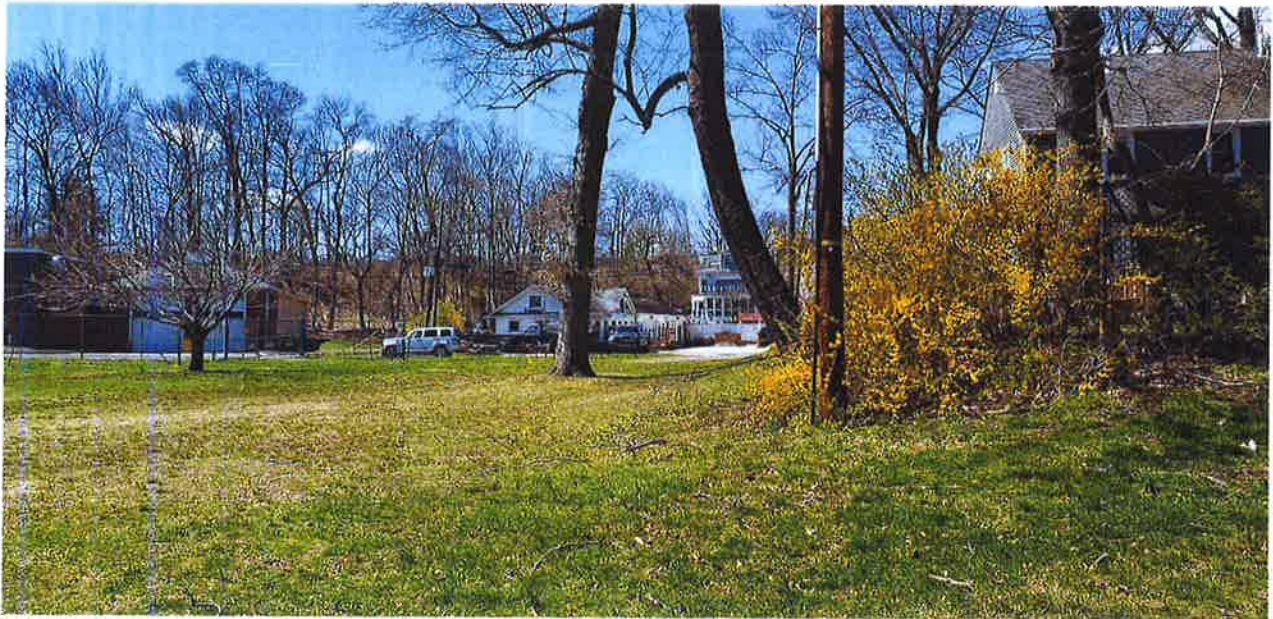
**Access for this playground area would be from nearby Morris Court which is a dead-end street. The flat terrain in this area would allow for easy creation of an accessible pathway from the street.**

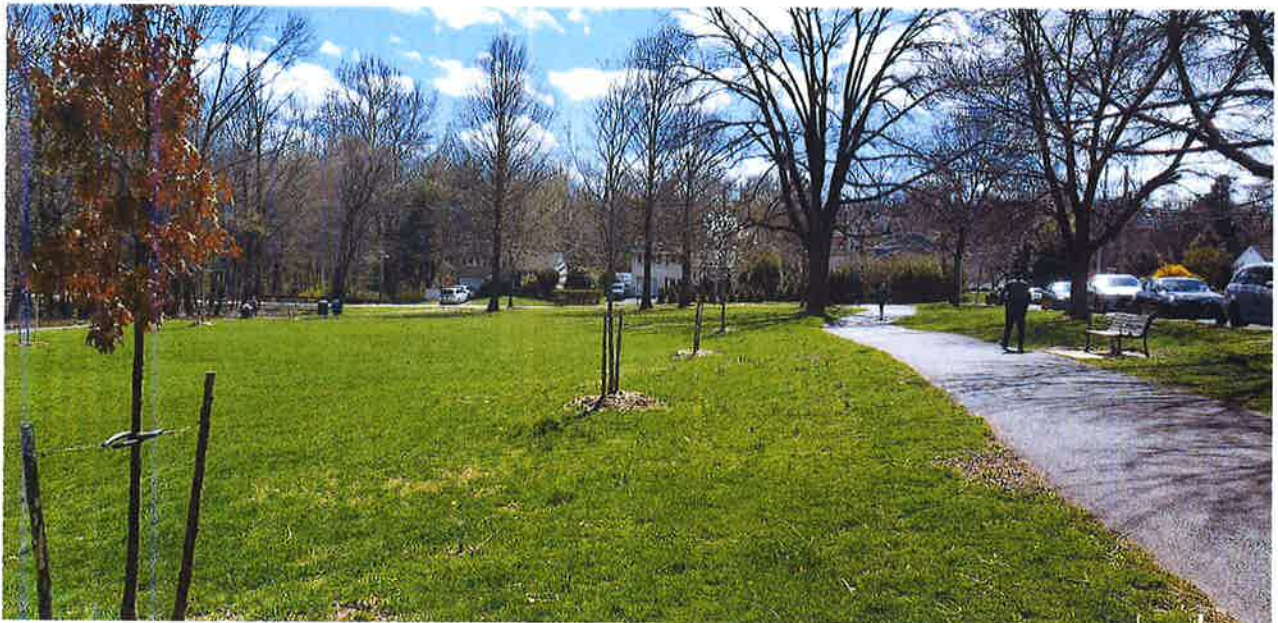
**View of potential playground location at Briant Park looking south toward Orchard Street. The lawn area to the left of the path ranges from approximately 50' to 100' wide and could potentially accommodate a playground area, cars parked along Briant Parkway visible on the right side of the photo.**

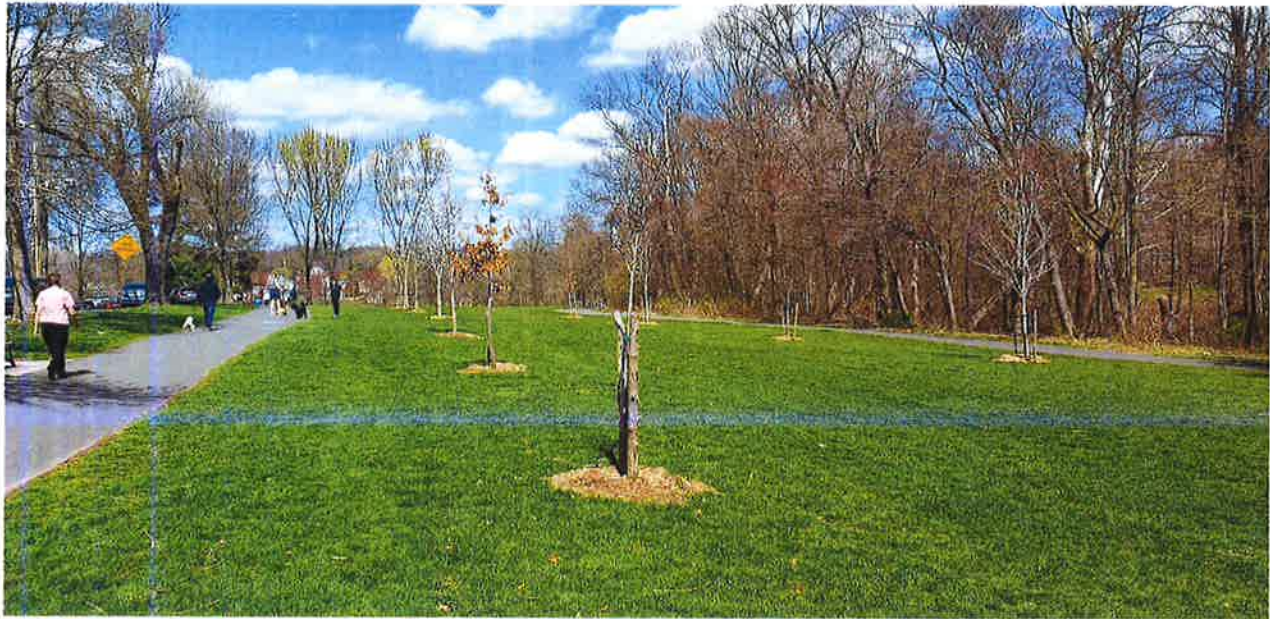
**View looking north at the first potential playground location within Briant Park. The open lawn area begins to narrow moving north and does not provide as much space to accommodate a playground, especially with the existing shade tree plantings.**

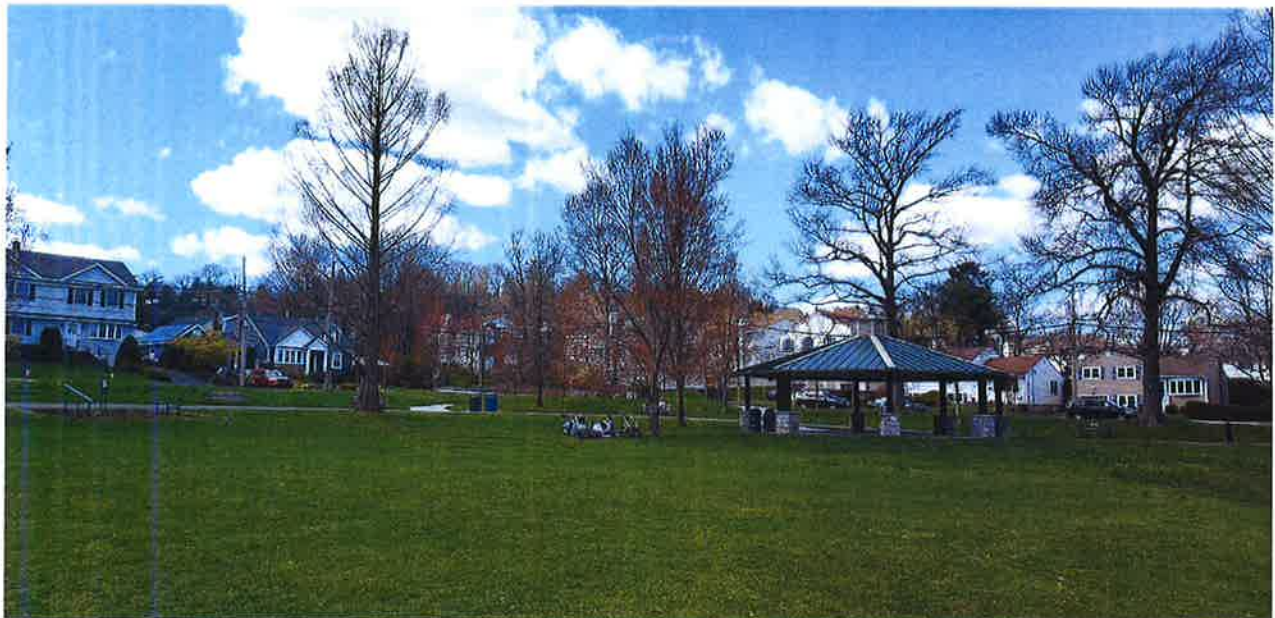
**View of the second potential playground location within Briant Park. This potential location is located in the northwest corner of the site near the existing pavilion structure. This area is flat, open and could accommodate a large playground. Fencing would be necessary for safety as this location is close to Springfield Avenue.**

As stated above SCE recommends constructing a new playground near the existing pavilion in the northwest corner of the park. This area is large, open, and relatively flat which will allow for minimal site clearing and grading. Since this is a large County Park and highly visible from busy Springfield Park, SCE recommends installing new playground equipment from a reputable playground equipment manufacturer that is eye-catching and will attract users to the park. The playground could be designed with a theme in mind, such as nature with an emphasis on freshwater wetlands and streams given the proximity of this playground location to Briant pond. Equipment could be selected that has custom designed pieces such as posts designed to look like cattails or stepping pods resembling lily pads. Additional nature themed equipment could be spread around the area such as log tunnels, mushroom steppers and climbing boulders.

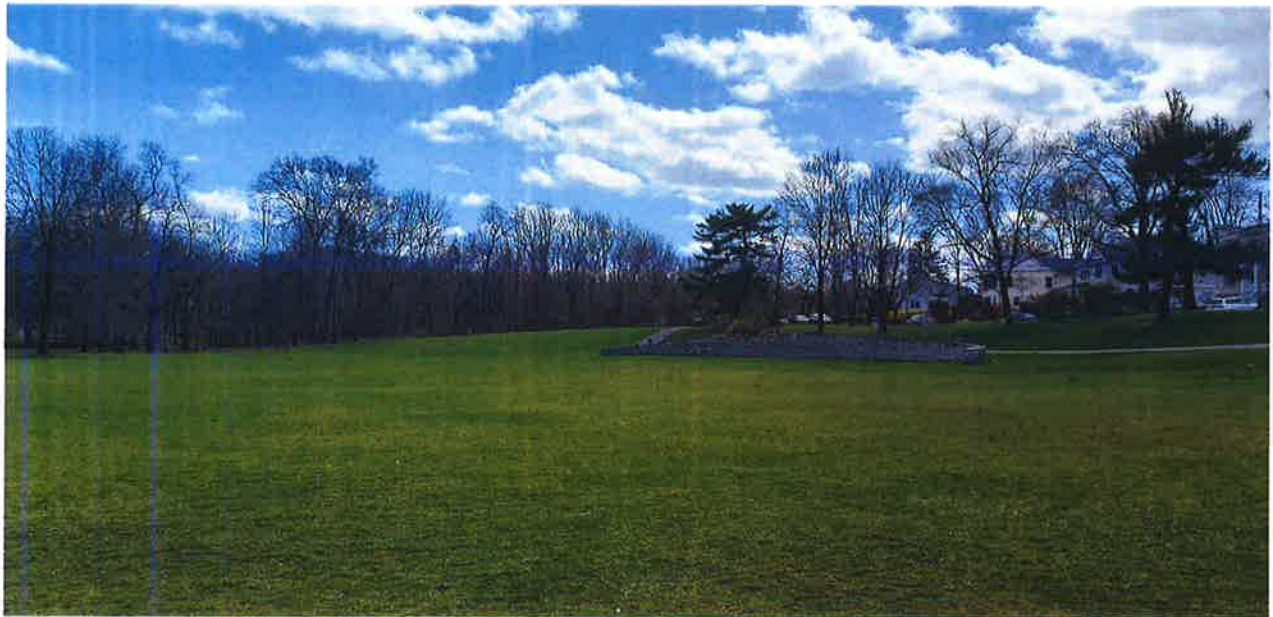
**View looking south from the second potential playground location. This image serves to characterize the flat and open nature of this area.**

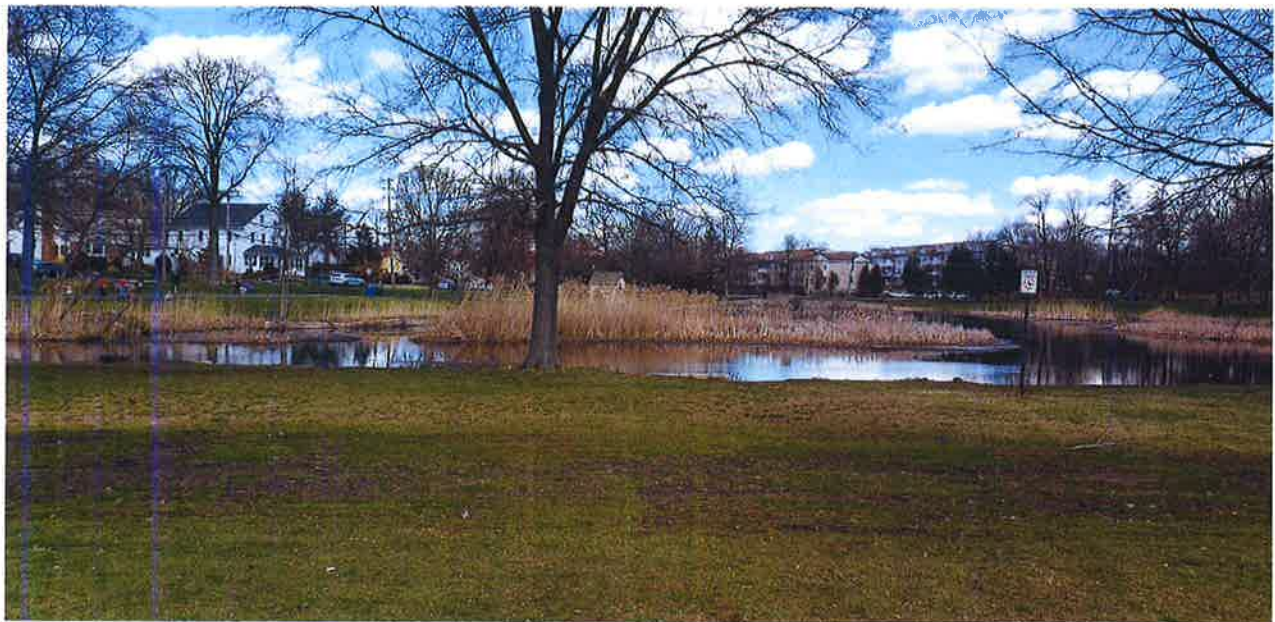
**View looking east at Brant Pond from the second potential playground location within Briant Park. Potential playgrounds should be kept as far from the pond as possible as the ground was observed to be saturated during the time of the site visit and flooding could be a potential problem.**
